THESIS TITLE LANDSLIDE FAILURES ALONG MT. BALDY ROAD AND TESTING OF METHODS TO BACK CALCULATE
AUTHOR Andrew Garcia
PROGRAM Geology, M.S.

**LANDSLIDE FAILURES ALONG MT. BALDY ROAD AND TESTING OF
METHODS TO BACK CALCULATE SAFETY FACTOR**

The area around Mt. Baldy Road to the west of the San Antonio Canyon within the San Gabriel mountains is an area which has had a multitude of both small and large scale landslide failures during its history. The purpose of my study is to look at three small events (LS1, LS2 and LS3) that happened recently and investigate different methods to back calculate their safety factor parameters. I completed eleven trips to the area measuring orientations of fractures with the help of a GPS to constrain locations. Fractures plotted on stereonet revealed features needed to assess slope stability. A laser rangefinder was used in conjunction with ArcGIS to create high-resolution topographic maps in the areas near the landslides. These maps and related data manipulations facilitated volume calculation of debris cones and allowed me to estimate the missing volume at LS1 site.

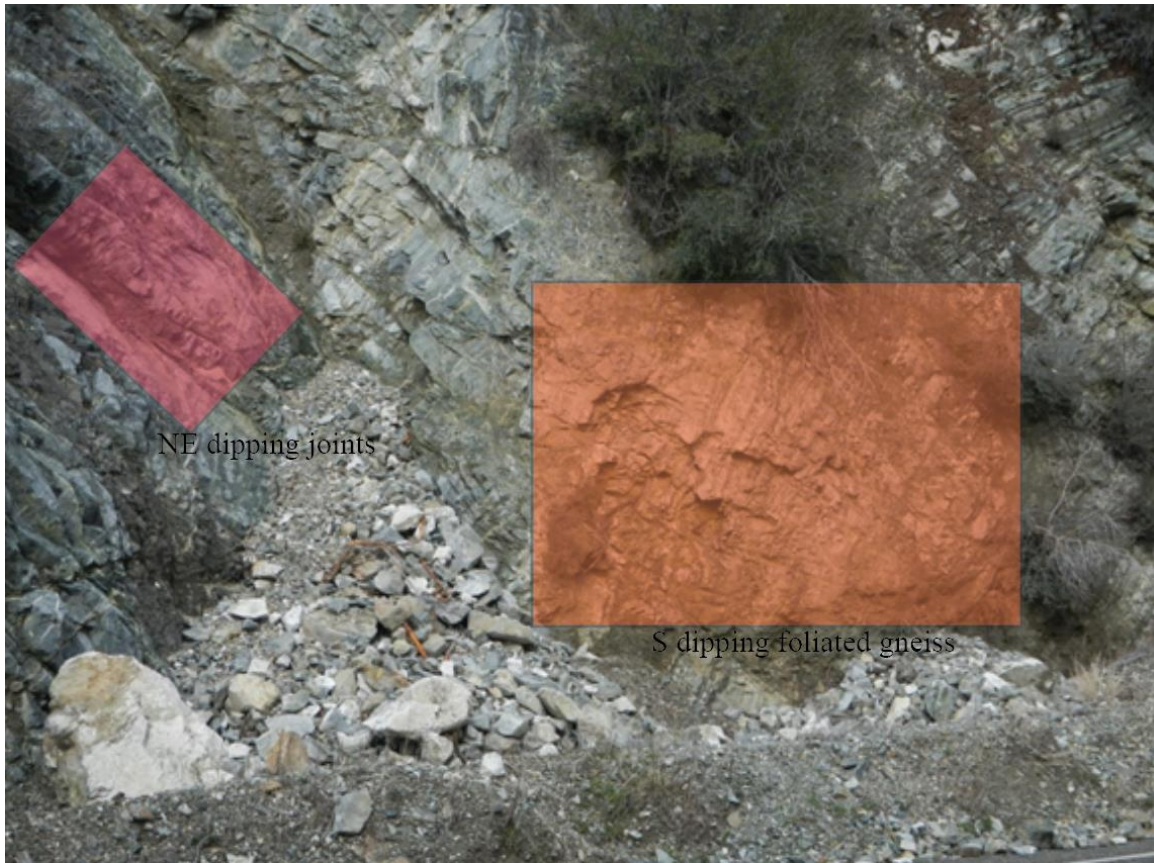
Figure 28: Wedge landslide photo from Feb. 8, 2017 taken by Dr. Nourse.

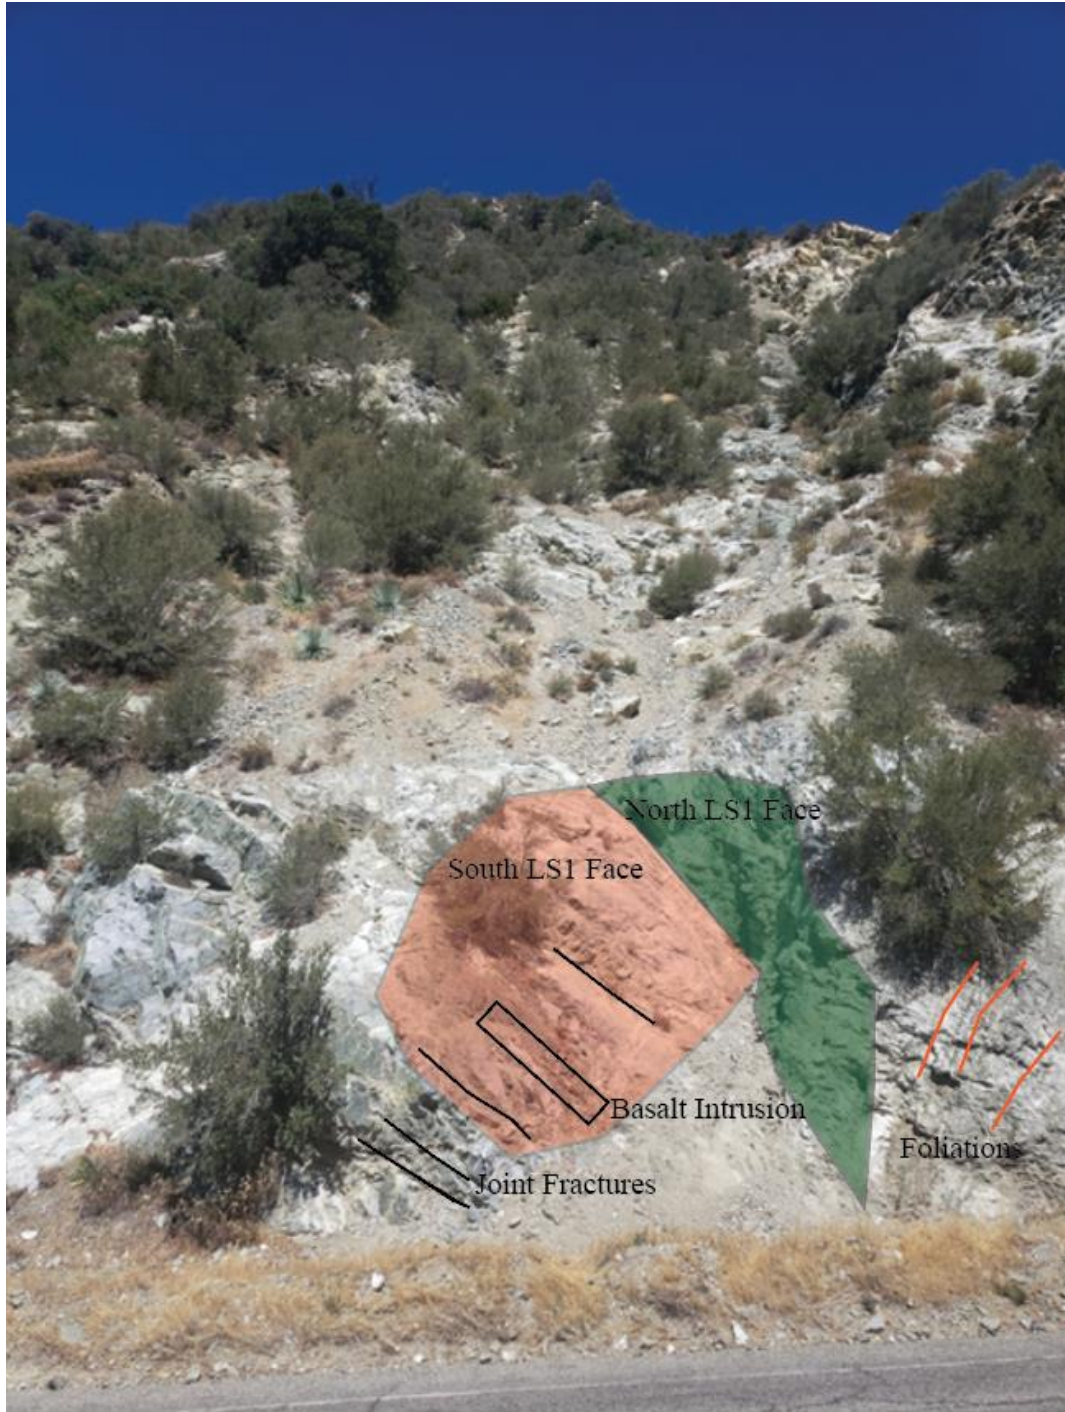
Figure 29: Image taken on July 20th, 2018 of the wedge after having surface cleared.

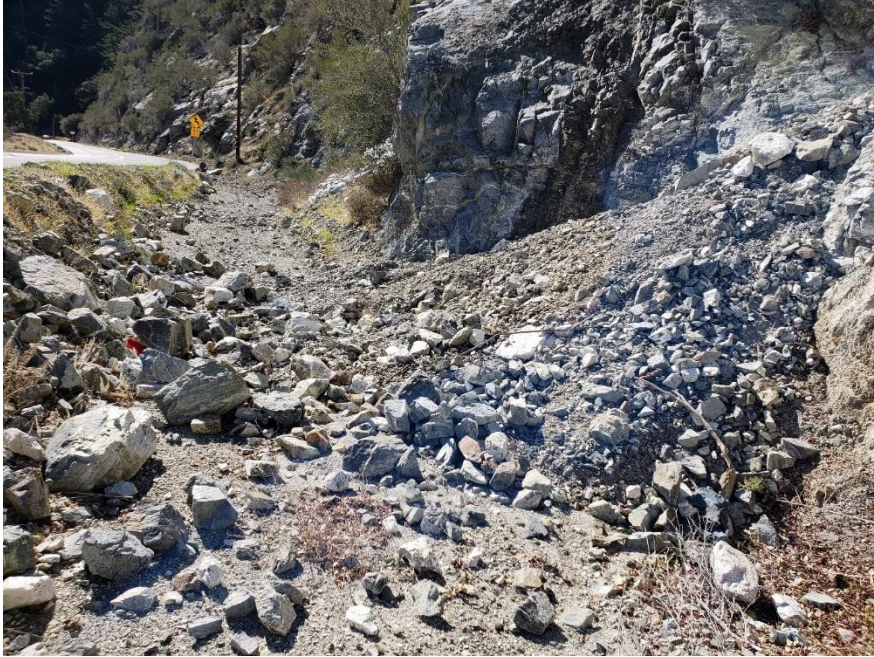
Figure 31: View looking south to the debris cone after winter storms from above wedge LS1 taken on 1/19/19.

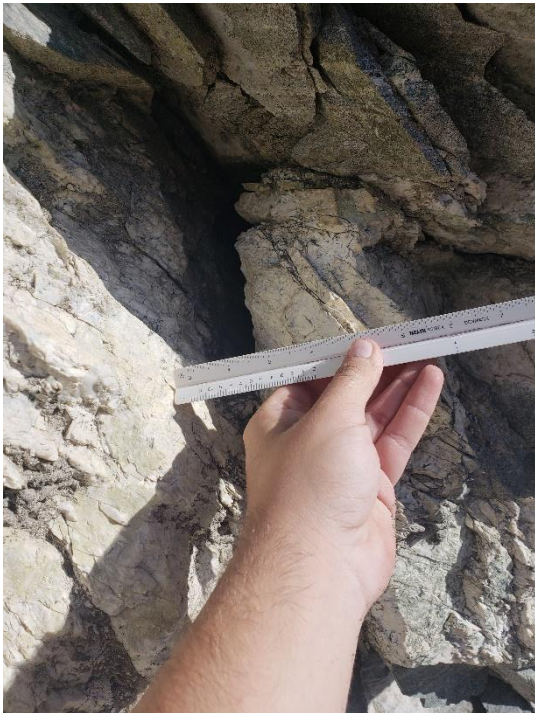
Figure 32: Fracture about 1.5 inches wide under the lookout.

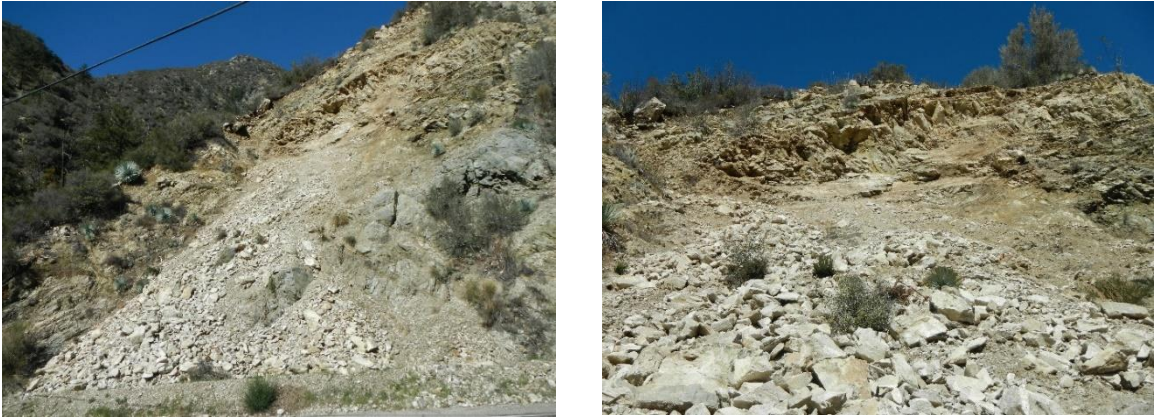
the intersecting fractures which caused for the wedge failures observed to the south, this area had only one plane of failure that was seen (Fig 34). Daylighting surfaces caused for these failures to happen without the necessity of another set of fractures or joints aside from the fractures which occurred along the foliation planes (Fig 35).

Figures 34 and 35: Photos showing the failed landslide surfaces taken on February 11, 2019, by Dr. Nourse.

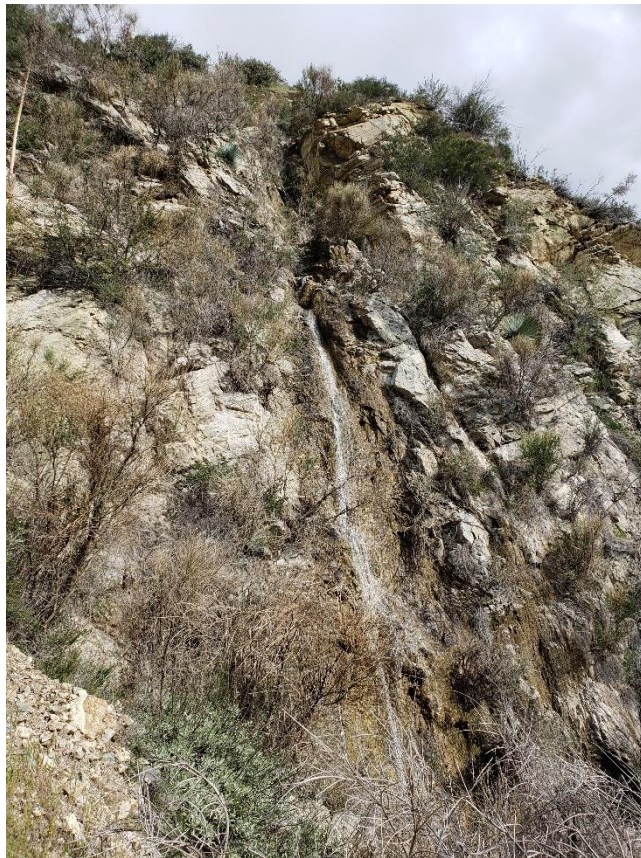
Figure 37: Potential mini wedge with small waterfall above the Sierra Powerhouse Access Road.

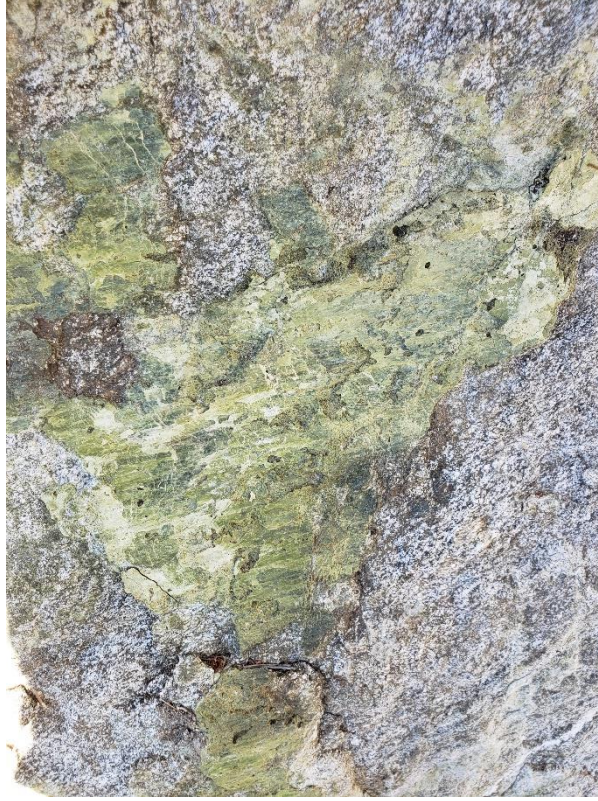
Figure 40: Striated epidote fault surface on south face of LS1 better exposed in light.

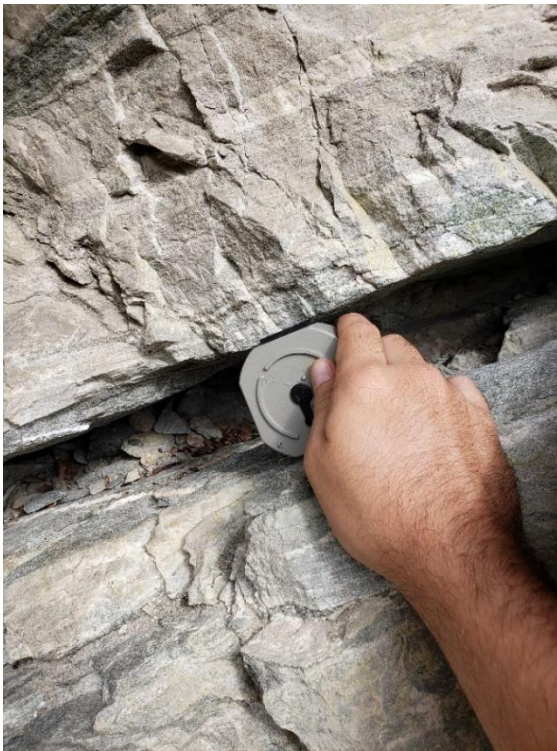
Figures 41 and 42: Figure 41 (left) shows the size of a fracture along the foliation plane in the felsic gneiss by the Sierra Powerhouse Access Road with Figure 42 (right) showing my mom taking notes from measurements.

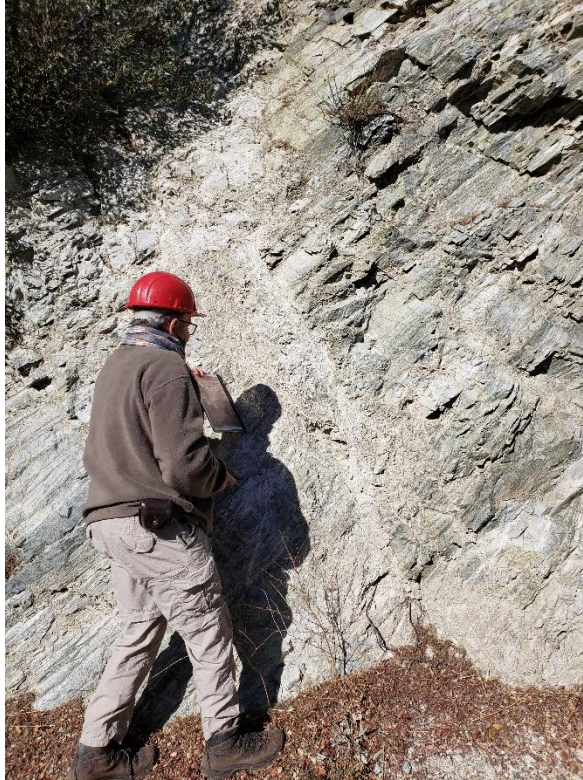
Figure 44: Dr. Nourse measuring a brecciated fault near LS2 on October 30th.

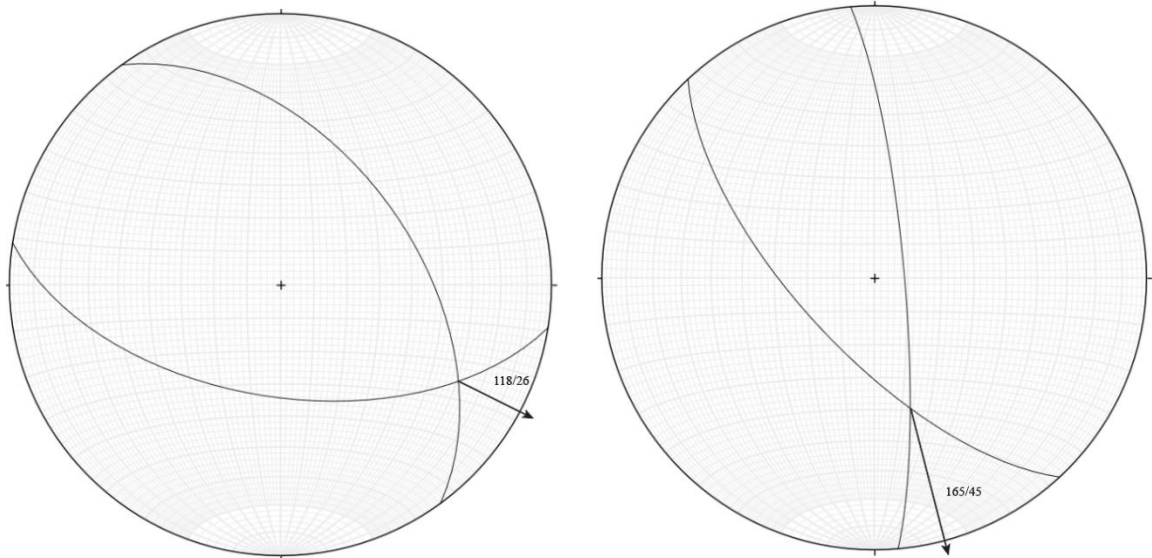
Figures 50 & 51: Showing two potential small wedges north of the Sierra Powerhouse Access Road which were sighted from afar.

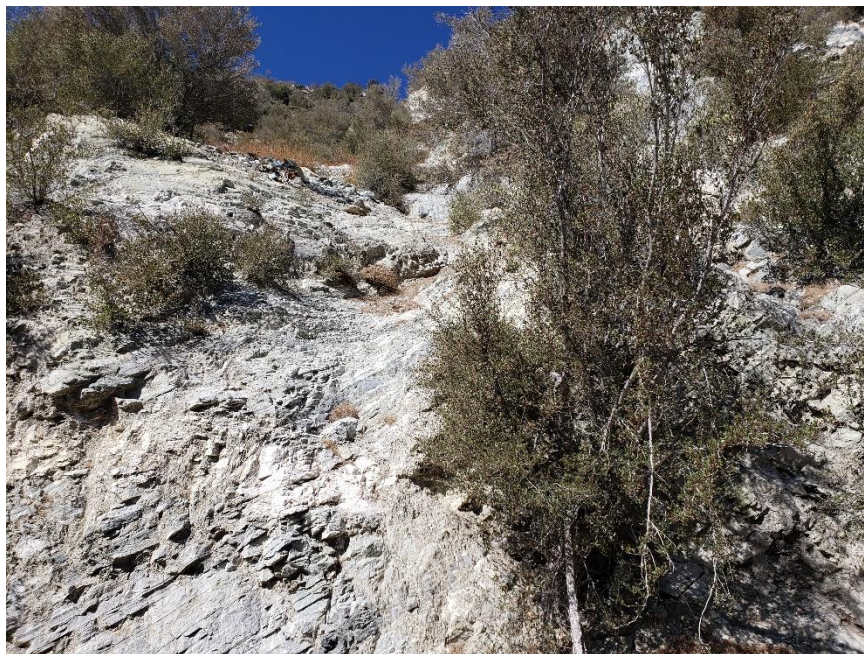
Figure 54: Photo taken of LS2 showing wedge features.

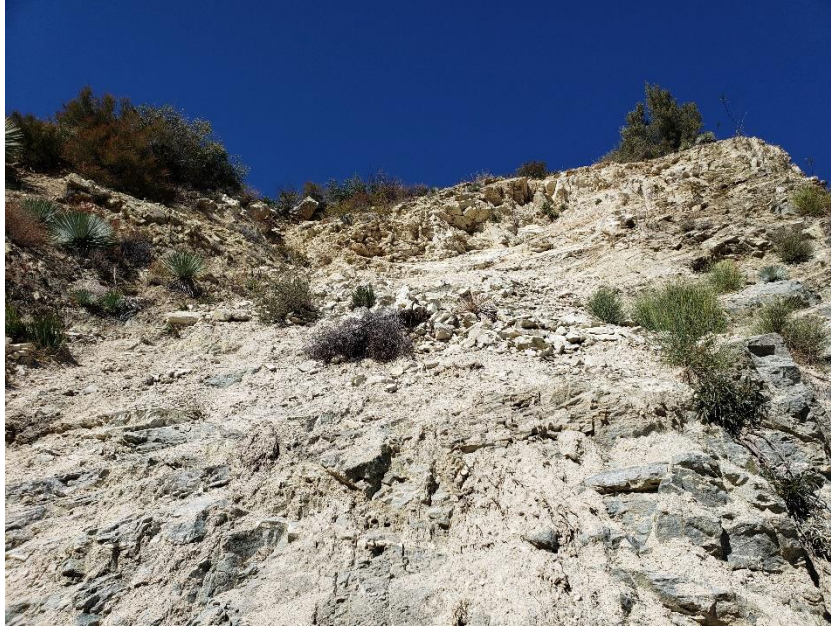
Figure 55: LS3 towards the top of the image with the breakaway point the steep surface on top. Seems to have a planar surface.

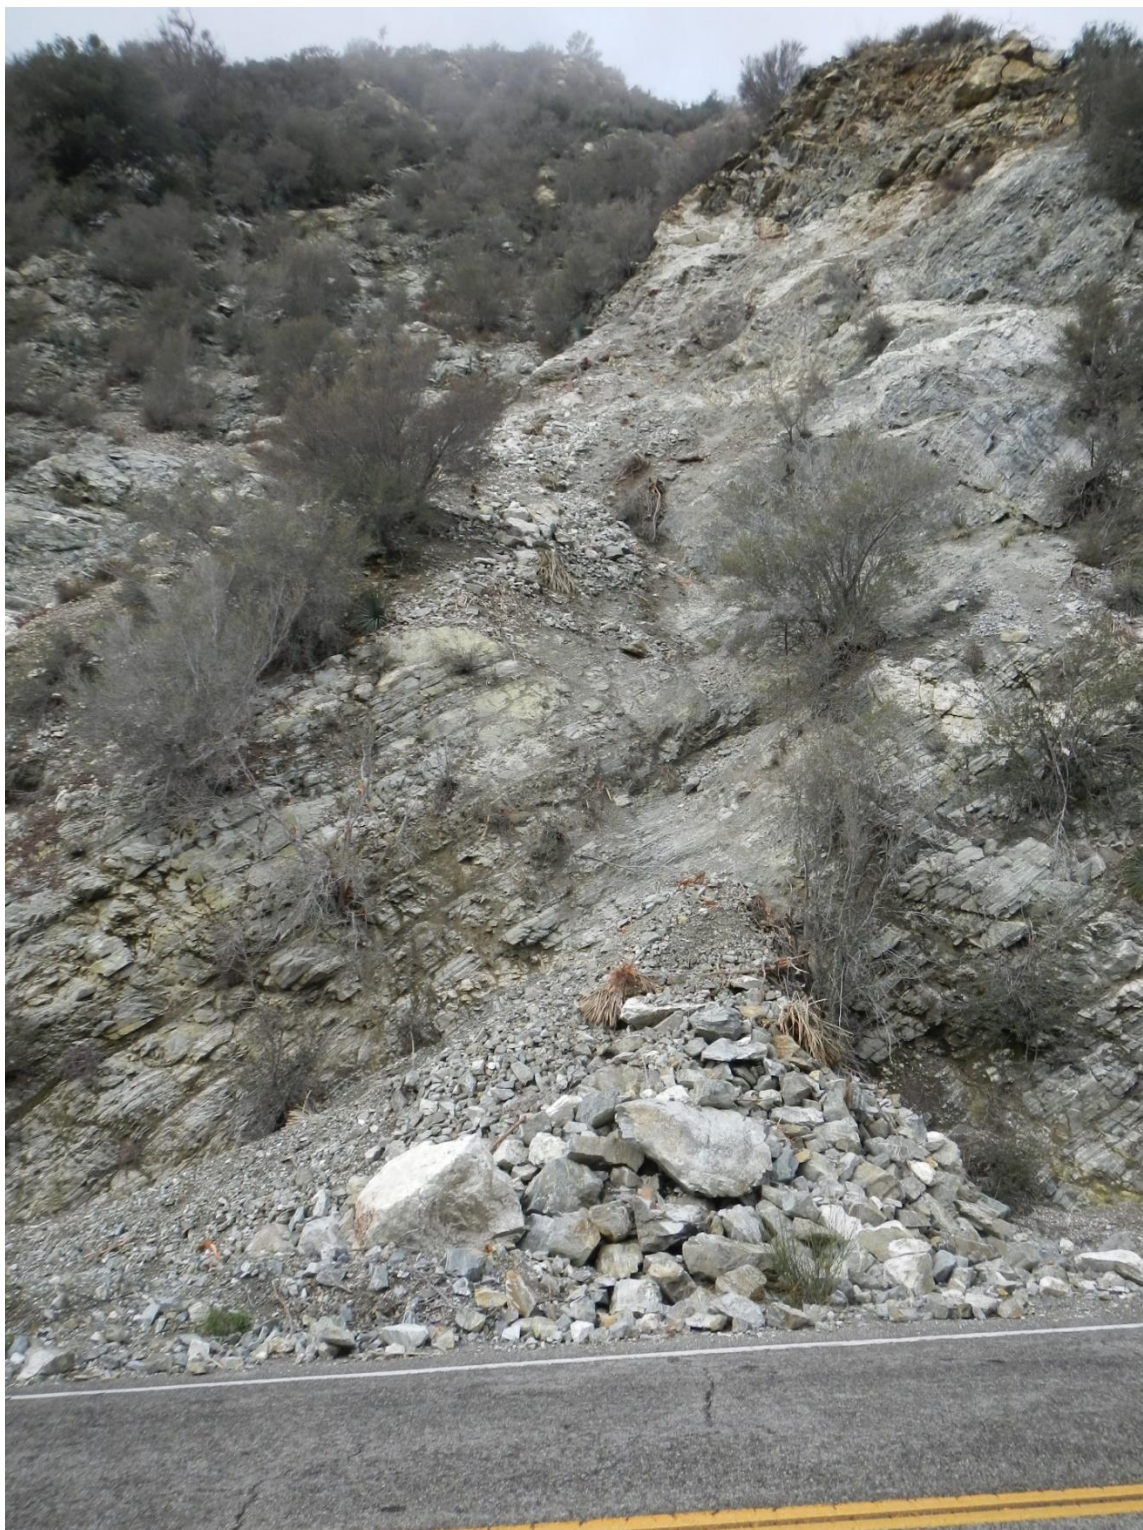
Figure 67: Photo of the cone of LS2 which was used to approximate dimensions by Laser Rangefinder after the debris were cleared. Photo taken by Dr. Nourse in 2017.

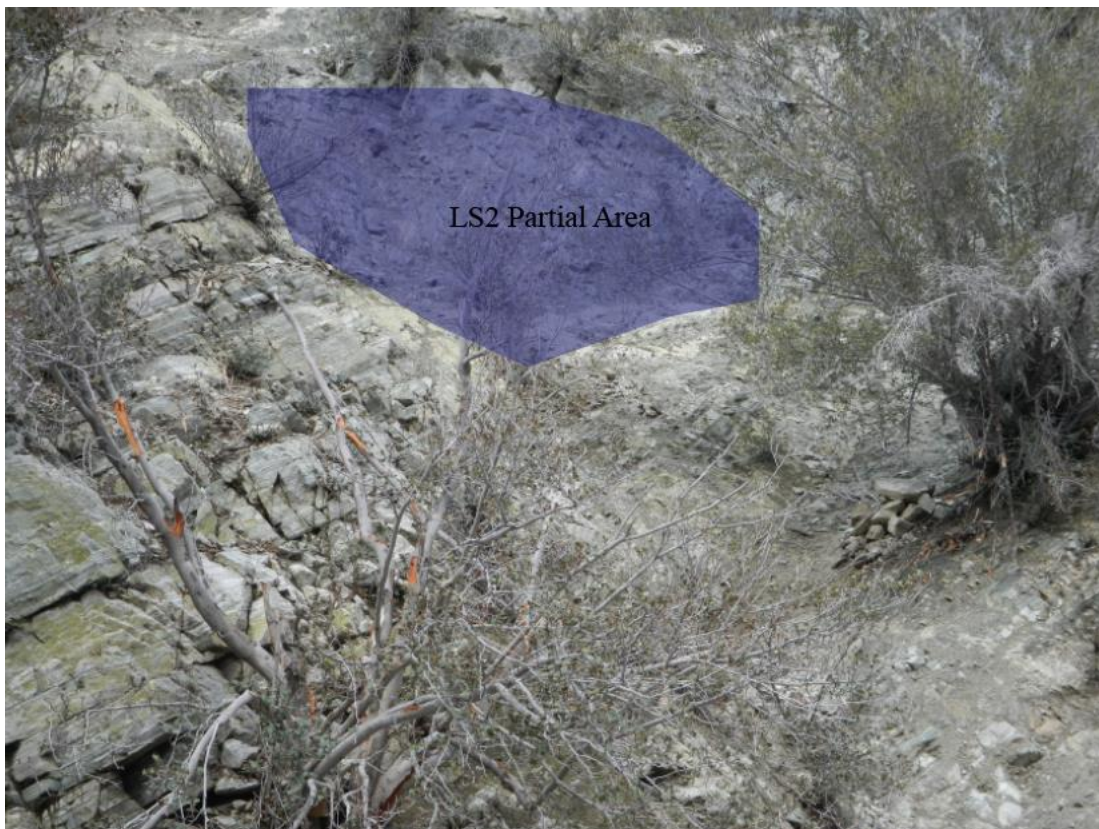
Figure 68: Photo of the failure surface taken by Dr. Nourse in 2017.

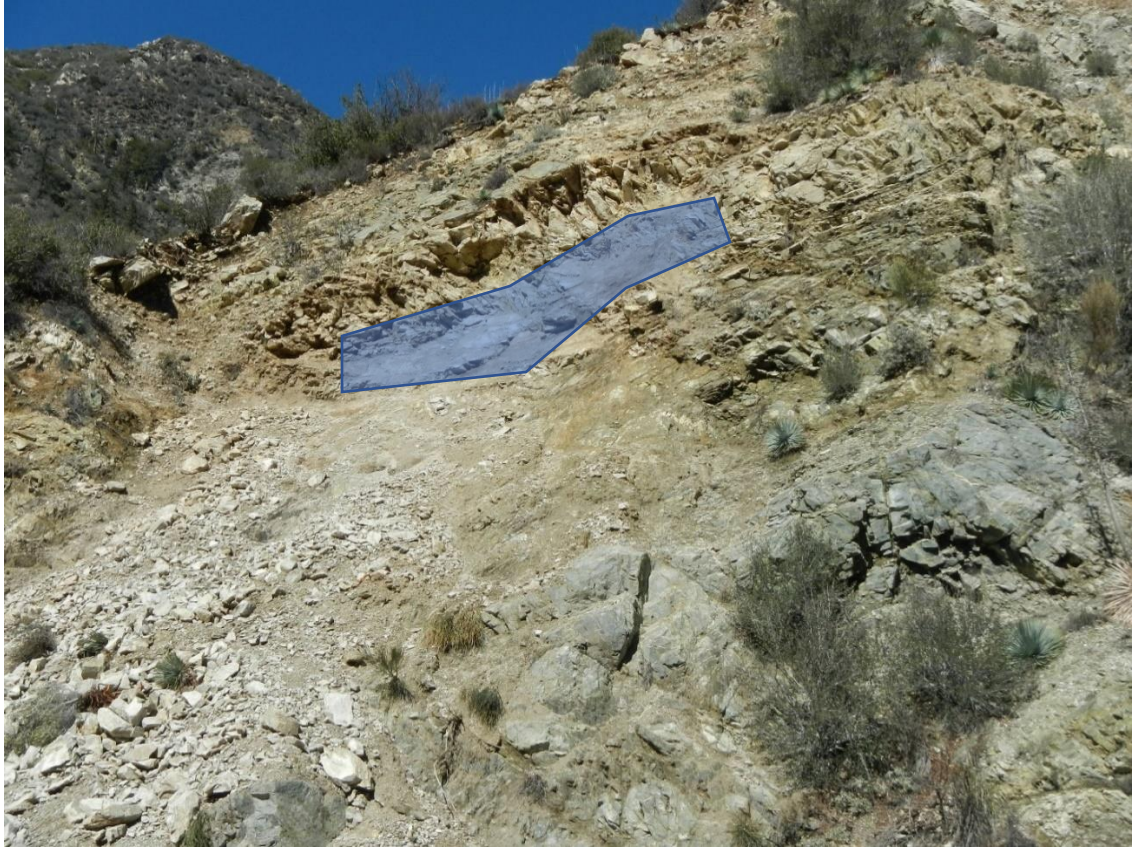
Figure 71: Photo of the failure surface of LS3 taken by Dr. Nourse on February 11, 2019. Suspected failure surface in blue. Some of the slide surface may still be buried so area could be larger. Scarp seen above the failure area.

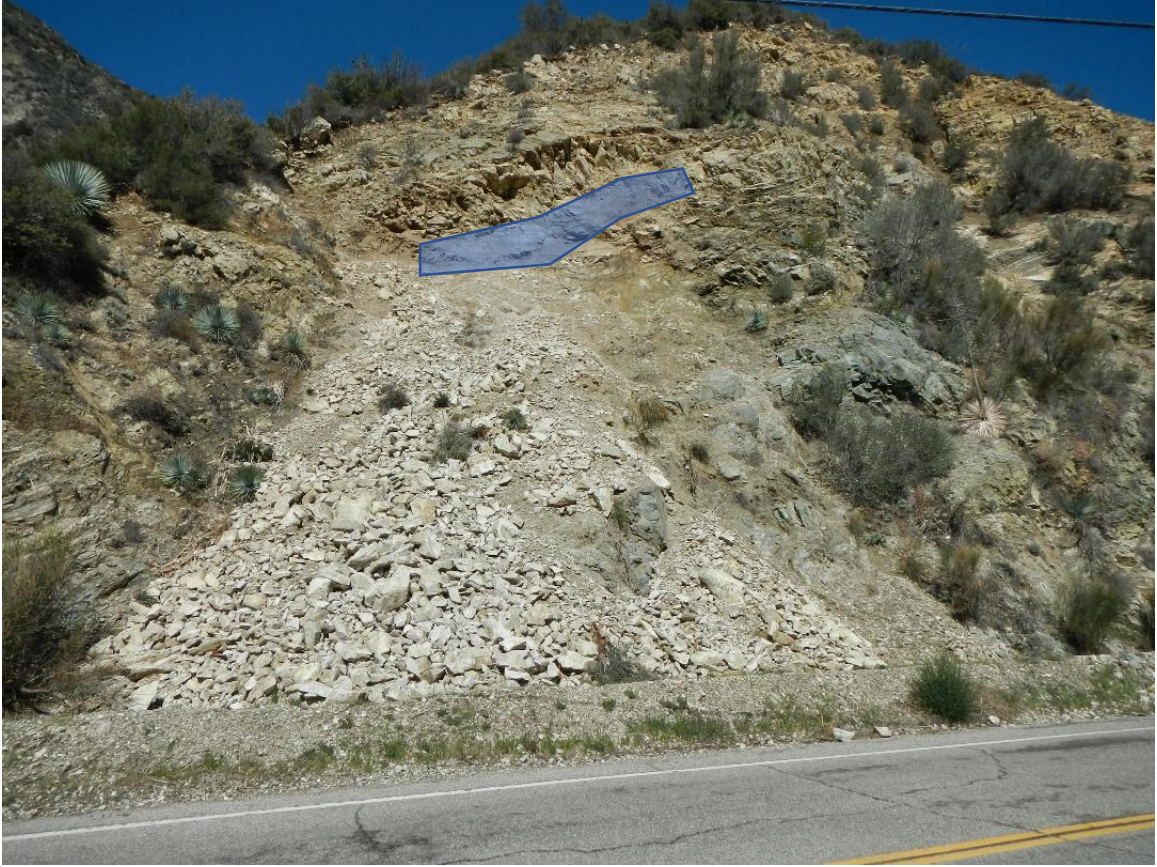
Figure 72: Image of the LS3 cone used to approximate the volume of material with slide surface in blue. Photo by Dr. Nourse February 11, 2019.

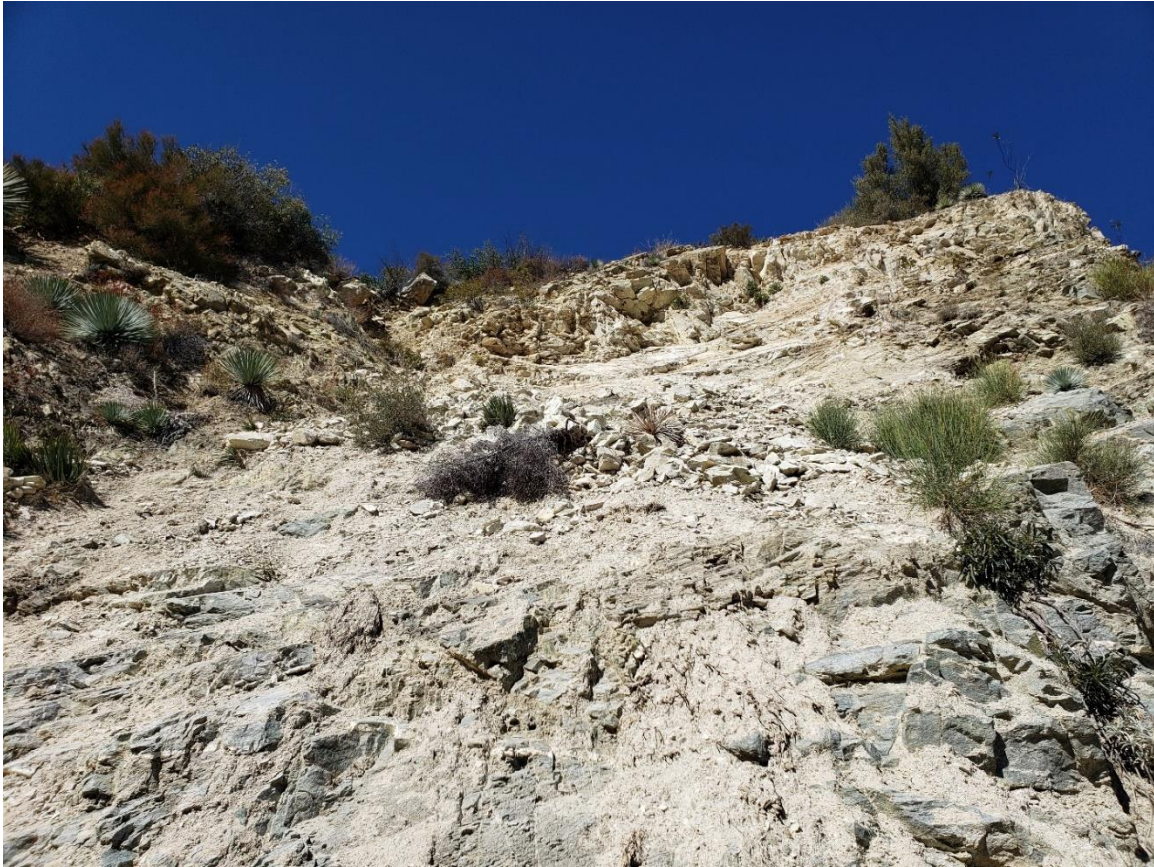
Figure 84: Photograph showing the LS3 failure surface up above.
