Failure Analysis of a Rockslide on Sunset Ridge Fire Access Road San Gabriel Mountains, California

By
Logan E. Wicks
Geological Sciences Department
California State Polytechnic University
Pomona, CA

2010 Senior Thesis
Submitted in partial fulfillment
of the requirements for the
B.S. Geology Degree

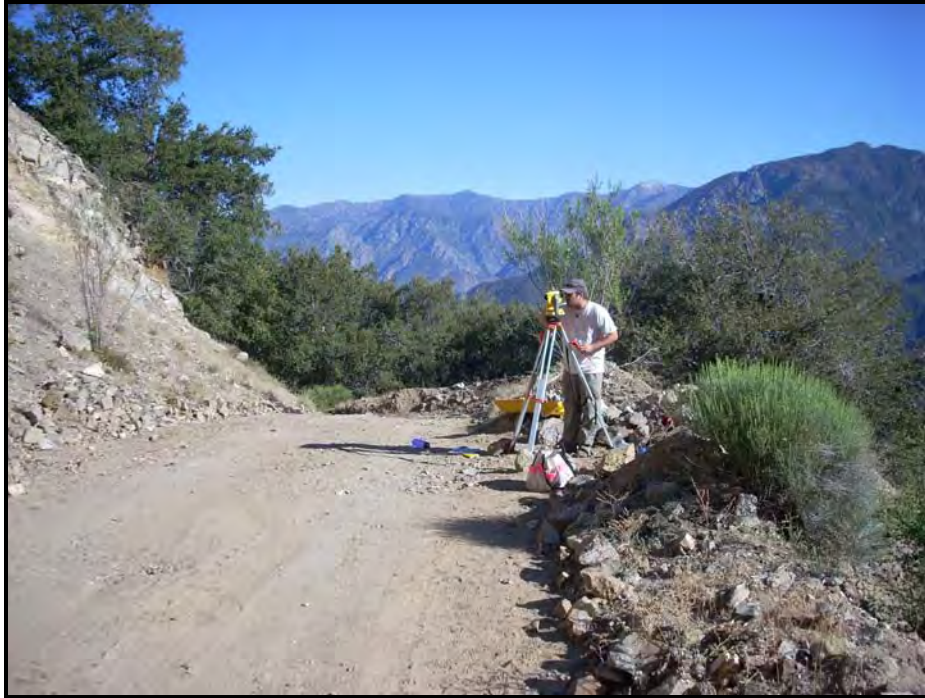
Figure 4. Surveying using the Trimble Total Station on the fire access road directly beneath the landslide scarp.

Data collection was accomplished by taking field measurements with both Brunton compasses and surveying equipment (Trimble Total Station). The Trimble Total Station is an optical surveying instrument that has a theodolite, electronic distance meter, and GPS which can be used to measure distances to a certain point. To operate this Total Station, one person would go up the desired coordinate location with a reflective marker at the top of a staff, of which the length is known. This length is entered into the Station along with the Station's height to land surface (measured from the base of the Station to the ground). The operator then aligns the cross-hairs of the Station with the marker (Figures 4 and 5).

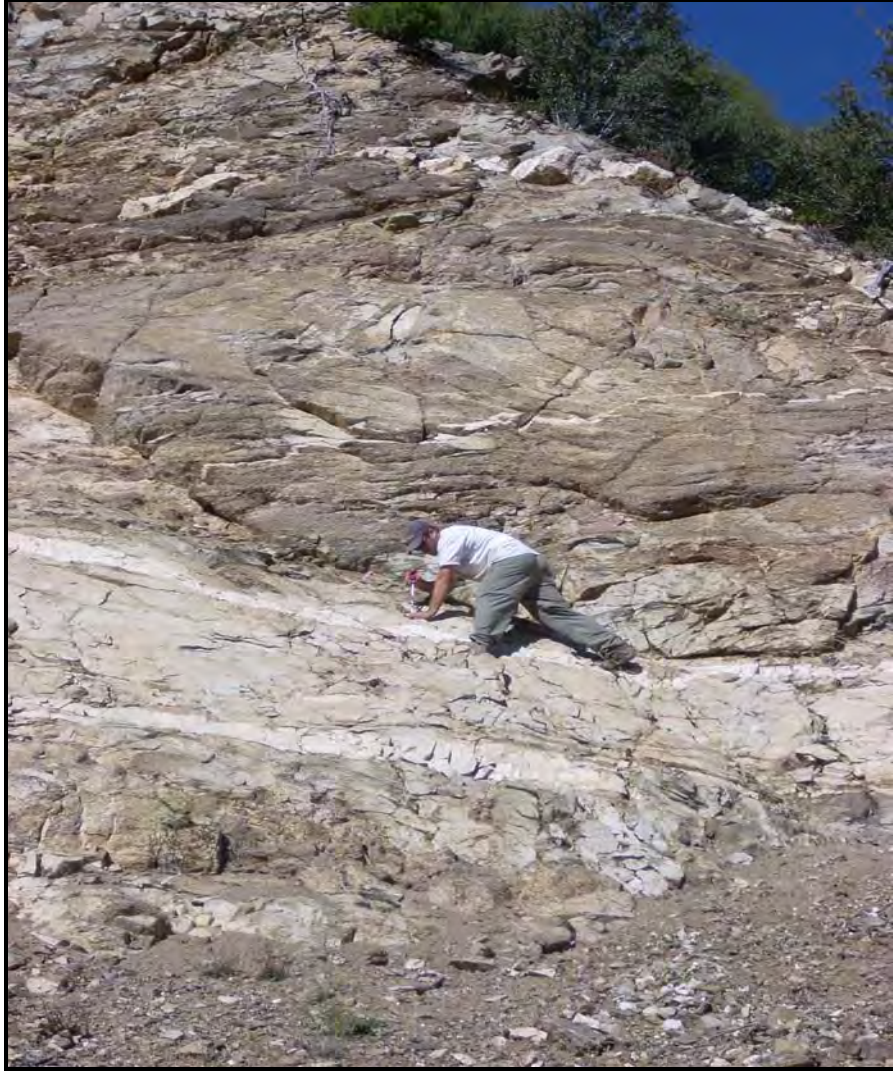
Figure 5. Using the surveying prism to mark the daylighting fracture which is oriented sub-parallel to the lower slide surface.

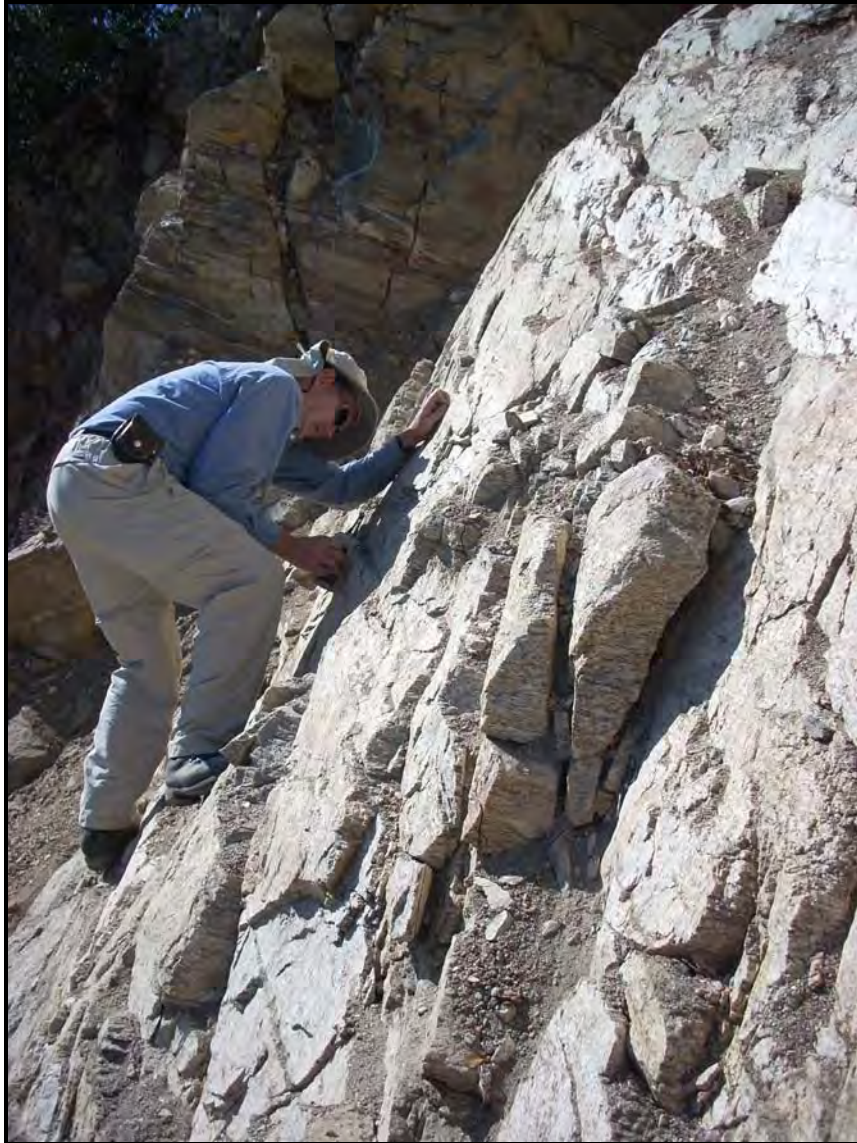
Figure 6. Taking strike and dip of a set of fractures oriented with the steep back release surface.

The station emits a laser and is able to determine the position of the point in space from the reflection received from the marker. This position is given in the form of x, y, and z coordinates. Bunton compasses were then used to measure the strike and dip of various structural features corresponding to surveyed points (Figures 6 and 7).

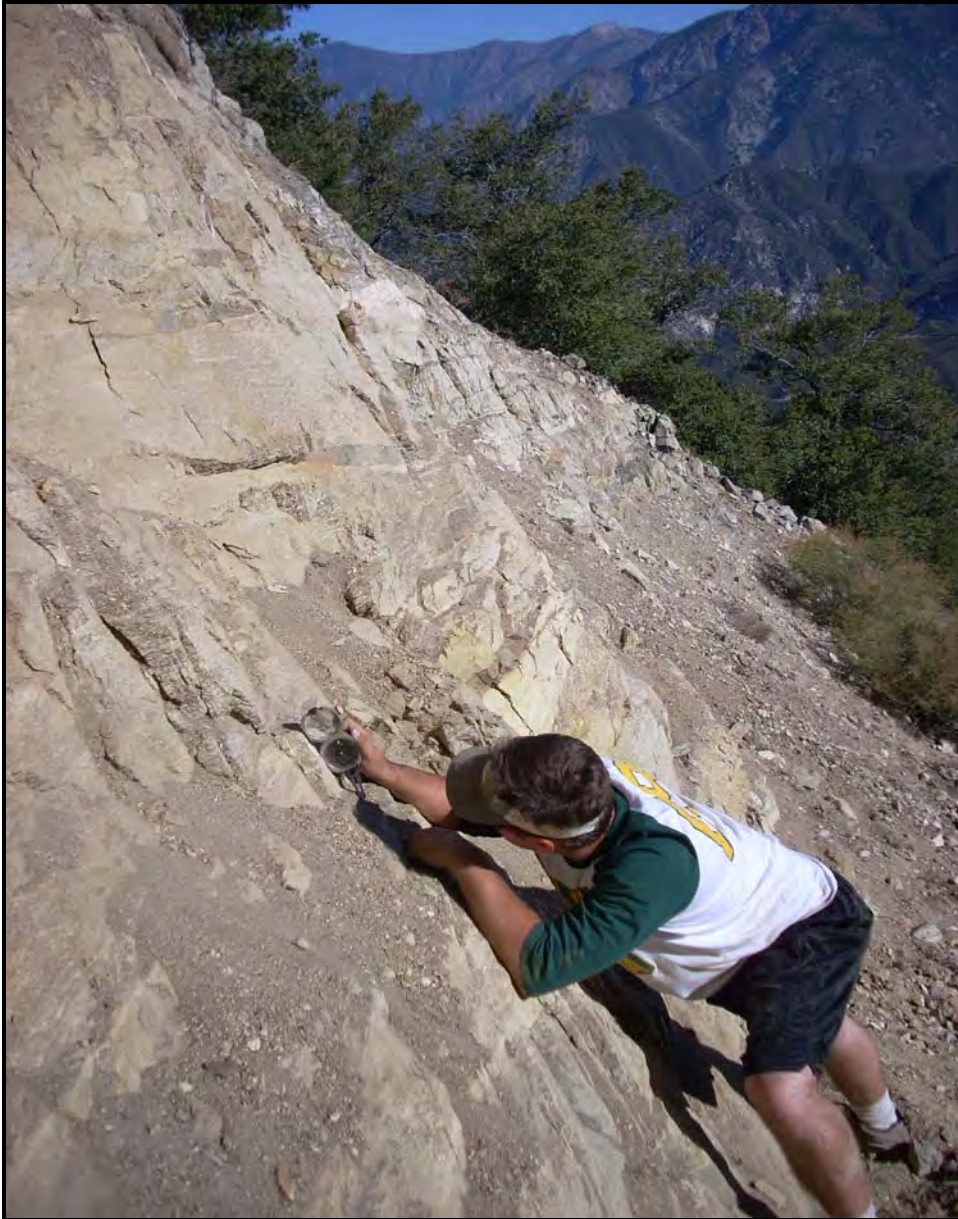
Figure 7. Measuring the steep dip of the back release surface. This is looking towards the North West.

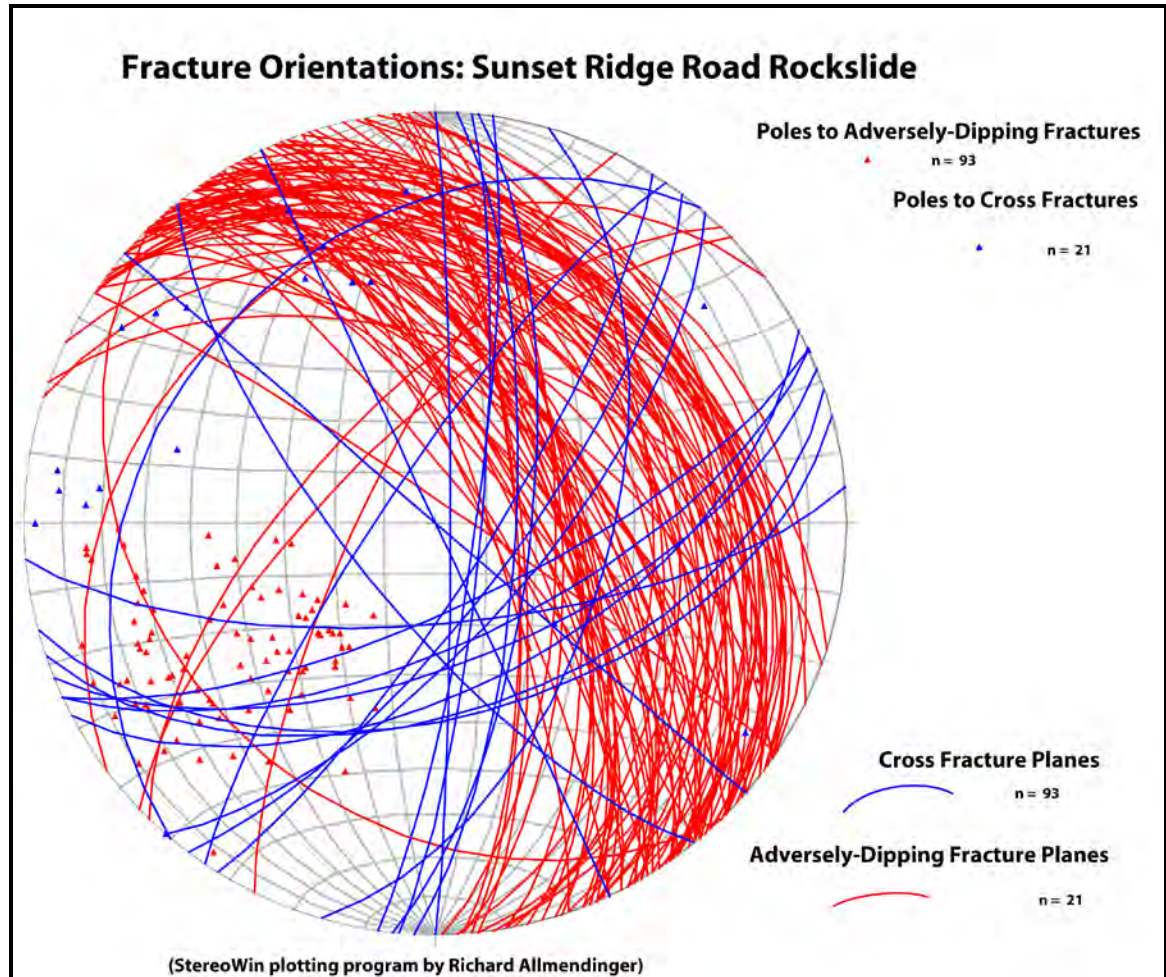
Figure 11. The fractures or joints fall into two groups: North east striking with steep dips, and North West striking with moderate to steep North East dips.

Different plots were made for fracture orientation (Figure 11), fault orientations (Figure 12), and metamorphic foliation (Figure 13). Using these plots, it is possible to see the general trend of these planar features and their typical orientations.

Fault planes in the landslide area do not plot in one specific orientation but consist of faults that dip to the NW, NE, and SE with dips generally between 50 and 70 degrees. Foliation orientations in the metamorphosed granodiorite plot consistently with a NE trend and NW dip of about 30 to 40 degrees. Fracture joint sets fall into two primary groups: those that strike to the NE with a steep dip to the SE, and those that strike to the NW with a moderate dip to the NE. The fractures that dip to the SE represent cross fracture planes that lie oblique to the day-lighting trend of the majority of the fractures.

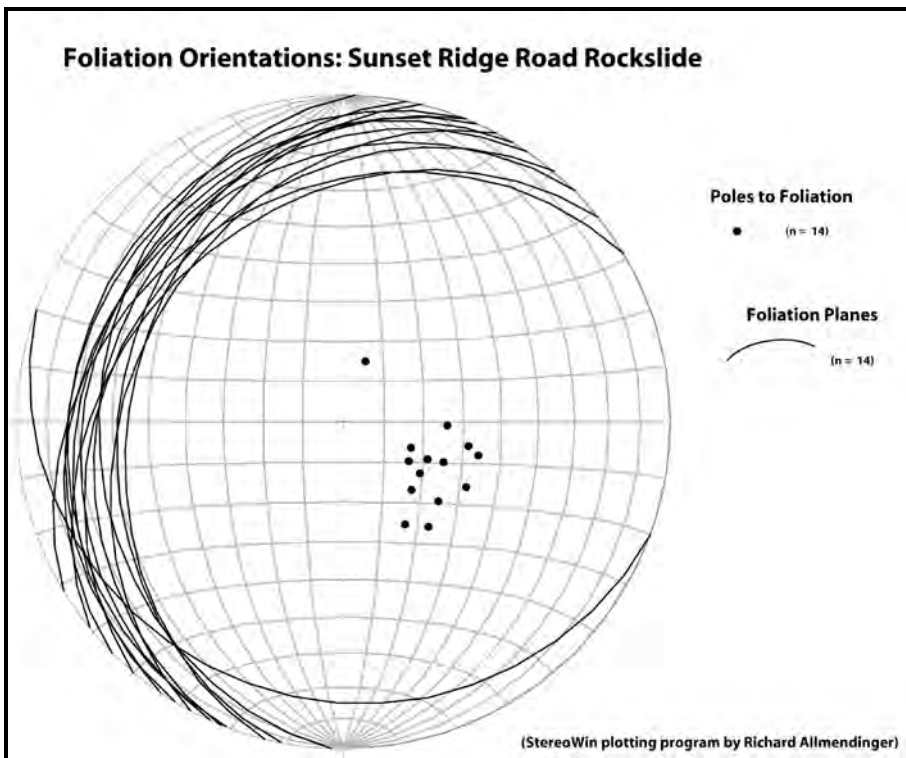
Figure 13. This stereonet is showing the metamorphic foliation dipping shallowly to the North West.

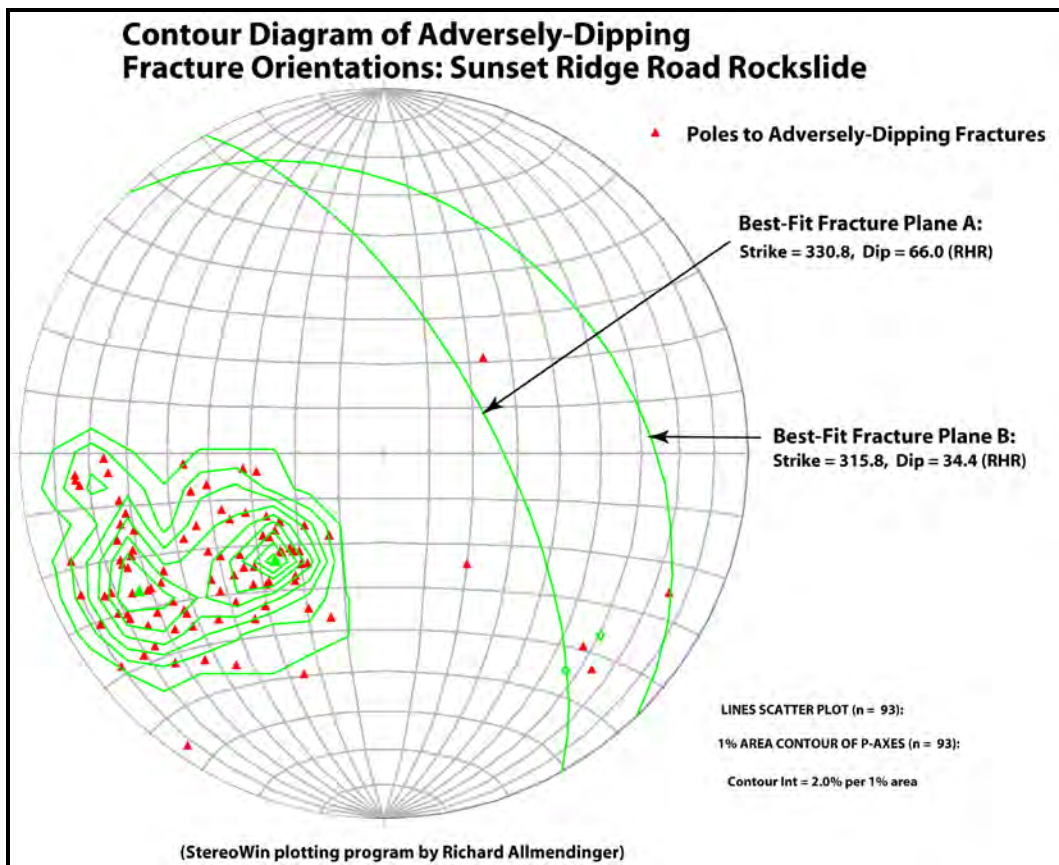
Figure 14 Adversly NE-dipping fractures from two dip populations. The shallower set corresponds to the basal slide plane, while the steep set marks the rear surface of the slide mass.

Most of the fractures dip to the NE and are referred to as adversely-dipping fracture planes. The adversely-dipping fracture planes themselves from two dip populations, (Figure 14).

In Figure 14, the poles of the adversely-dipping fractures were plotted and best fit strike and dip planes were found for these two dip populations. The shallower set

corresponds to the basal slide plane, while the steep set is generally parallel to the rear release surface of the slide mass. The best fit orientation of the shallow set is sub-parallel to the basal slide plane that was measured in the field (Figure 15), and used in the force diagram model and calculations for analysis.

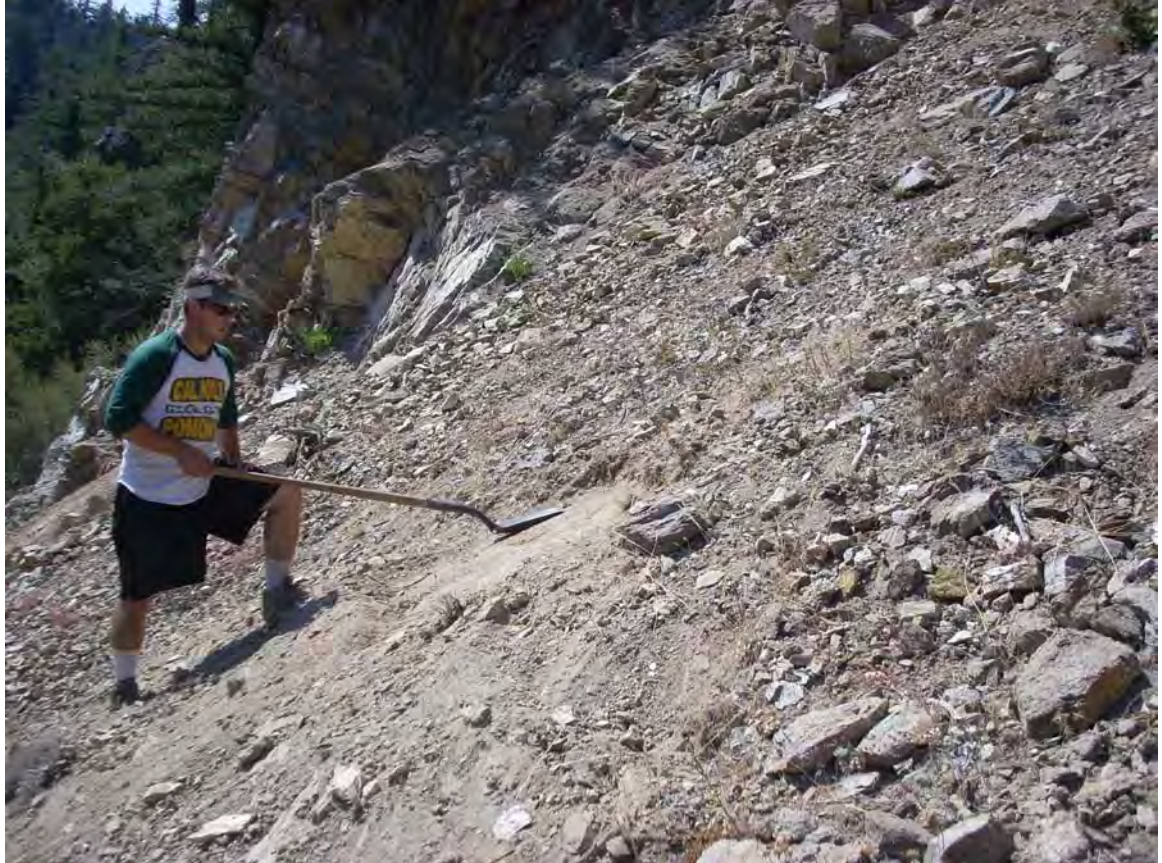
Figure 15. The basal slide plane is shown in the cleared section or slide and is roughly parallel to the shovel head.

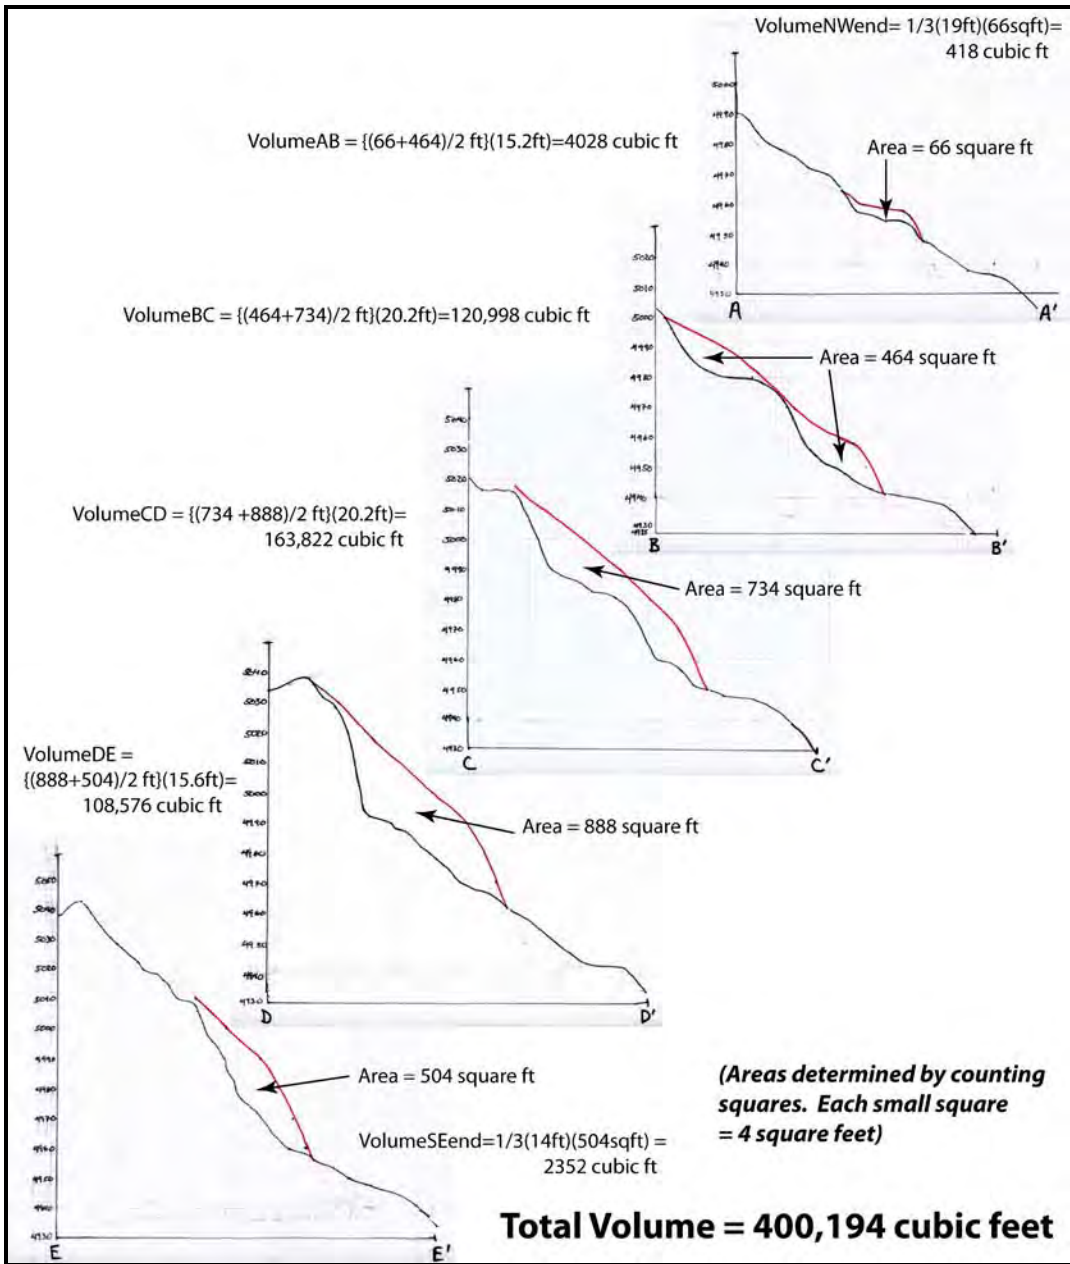
Figure 17. Drawn out profiles and calculations of the five cross-sections in figure 16

Then the pre-landslide hill surface was reconstructed by extrapolating from the waypoints taken on edges of landslide (redlines in profiles, Figure 17). The landslide area for each section is therefore represented by the area between the extrapolated surface and the existing surface. This area was calculated by counting the squares of the representative area on the cross section (each small square is equal to 4 square feet).

The areas on either side of consecutive cross sectional lines are averaged and then multiplied by the distance between them. This results in a volume for that “slice” of the landslide. For example, the landslide area from A-A’ is 66 ft² and the area from B-B’ is 464 ft². By taking the average of these two values results in an average area of 265 ft². This average area is then multiplied by the distance between the two cross sectional lines (15.2 ft), resulting in a slice volume of 4028 ft³. The total landslide volume was then

calculated by adding the four slices together as well as the volume estimated on the edges of the landslide. This total volume was found to be about 400,194 ft³. Multiplying this volume by a unit weight of 160 lbs/ft³ (a representative weight for crystalline rock) gives an estimated value of the landslide material dry weight of 64,031,040 lbs.
