THESIS TITLE LANDSLIDE FAILURES ALONG MT. BALDY ROAD AND TESTING OF METHODS TO BACK CALCULATE
AUTHOR Andrew Garcia
PROGRAM Geology, M.S.

**LANDSLIDE FAILURES ALONG MT. BALDY ROAD AND TESTING OF
METHODS TO BACK CALCULATE SAFETY FACTOR**

The area around Mt. Baldy Road to the west of the San Antonio Canyon within the San Gabriel mountains is an area which has had a multitude of both small and large scale landslide failures during its history. The purpose of my study is to look at three small events (LS1, LS2 and LS3) that happened recently and investigate different methods to back calculate their safety factor parameters. I completed eleven trips to the area measuring orientations of fractures with the help of a GPS to constrain locations. Fractures plotted on stereonet revealed features needed to assess slope stability. A laser rangefinder was used in conjunction with ArcGIS to create high-resolution topographic maps in the areas near the landslides. These maps and related data manipulations facilitated volume calculation of debris cones and allowed me to estimate the missing volume at LS1 site.

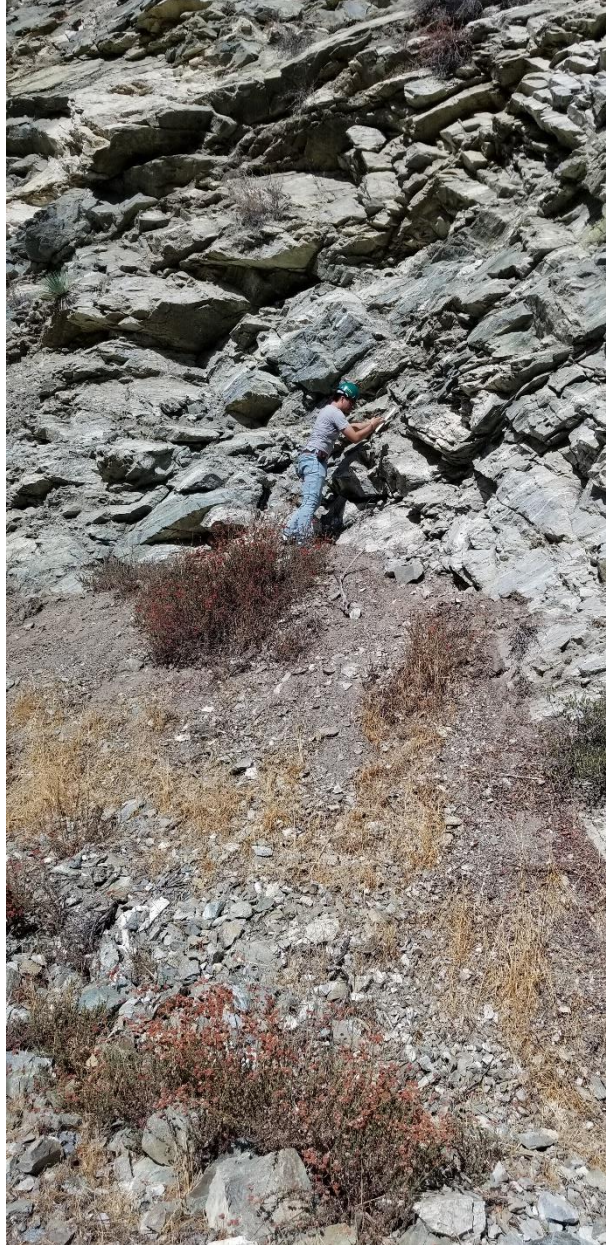
below Mt. Baldy Road along the Sierra Powerhouse Access Road (Fig. 30). There were some features that could potentially have been miniature wedge landslides with their shape. Measurements were taken to confirm this later with stereonet analysis.

Figure 30: Measurements being taken below the lookout above the Sierra Powerhouse access road.

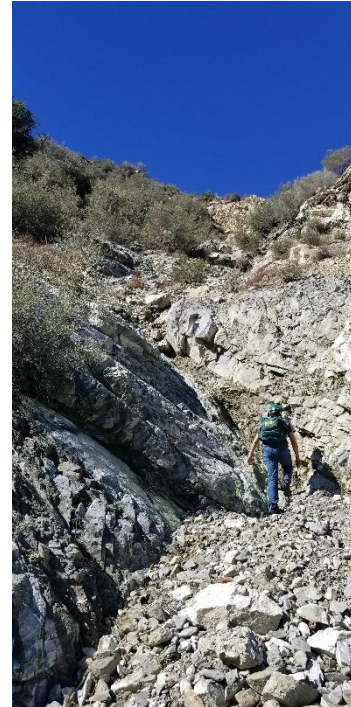
cone (Figs. 31, 33) had formed along the bottom of the wedge landslide LS1 that would allow for me to go up higher up in the landslide and get measurements nearer to the top of it which was about twelve meters above the base ground level. Recent rain events had also better exposed epidote patches along the southern side of the landslide to be able to get ten measurements of strike, dip and rake which suggests the past presence of a fault that cut through this portion of the landslide. Due to how unclear these rake striations were, determining the direction that the fault moved was not possible to do. LS2 was observed to the north of LS1 and seemed to have a similar wedge geometry. This area failed in the past and has similar fractures to those of LS1. We took one brief detour under the lookout to measure a fracture (Fig. 32). Temperature began to drop quickly as the sun went over the ridge which forced my mom and me to call it a day and head back home.

Figure 33: Hiking on the cone after a storm in the wedge. (LS1)

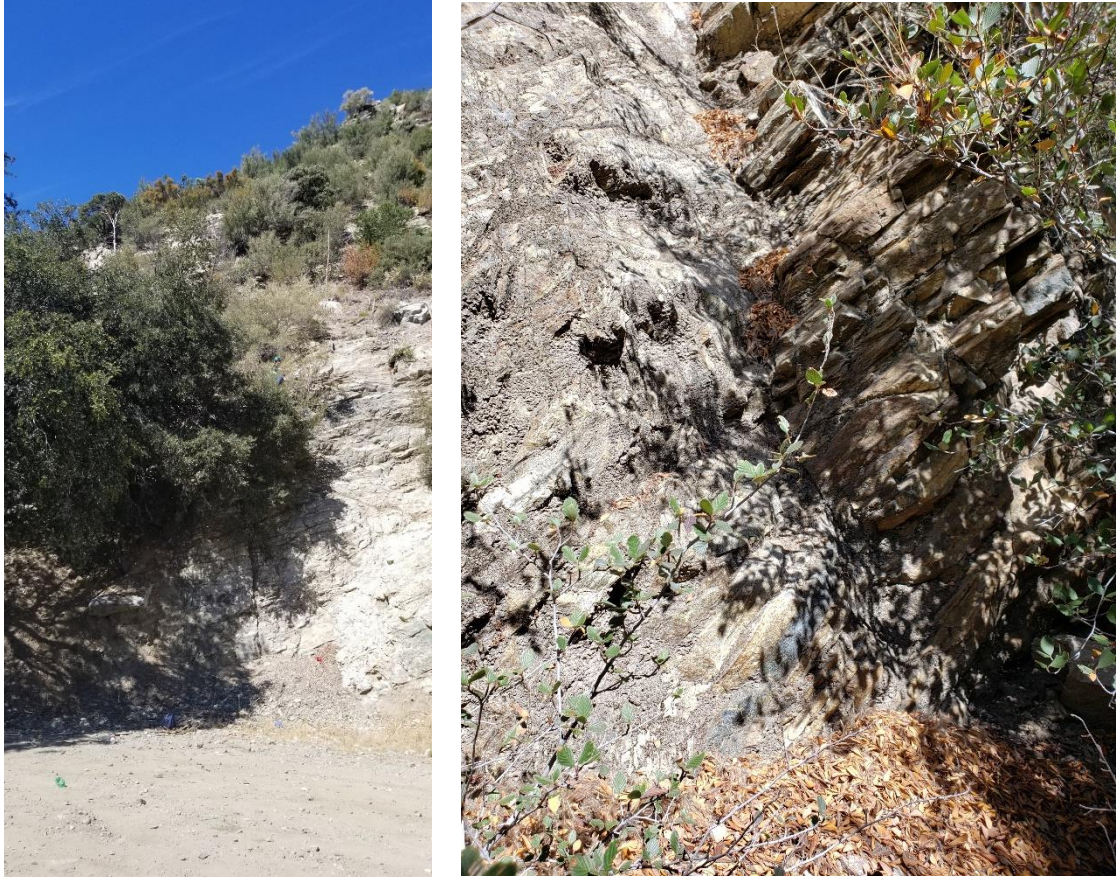
Trip number six on July 30th involved me going to do some research around the area of the parking lot north of the original landslide (LS1) location (Fig. 38) listed as above parking in Fig. 27c. Right away, it was apparent that the walls on the southern side of the parking area was mostly the gneiss that comprises much of the field area north of LS1 showing a clear division between the two parts. Foliation dips were consistently to the southwest which was the same dip direction as that observed on earlier trips to the landslide. Looking around revealed a path to get up higher onto the area which yielded many measurements which otherwise would not have been taken. Much of the gneiss had a brownish tinge to it from extensive weathering (Fig. 39) from weathering of biotite. This helps to distinguish the felsic gneiss from green diorite from quartz diorite unit which contains hornblende and epidote. Up high the dips were also consistent with all the other measurements that characterized the area. One of the other features seemed to be a little wedge like feature that happened along one of the fractures that ran through the rocks as there was a plethora of such fractures in the more heavily worn area. Twenty-four measurements were taken with waypoints attached to them via GPS later cross referenced with maps to ensure they were all in the proper spots.

Figures 38 and 39: Figure 38 (left) shows the area by the parking area where measurements were taken while Figure 39 (right) shows the weathered condition of the felsic gneiss up high.

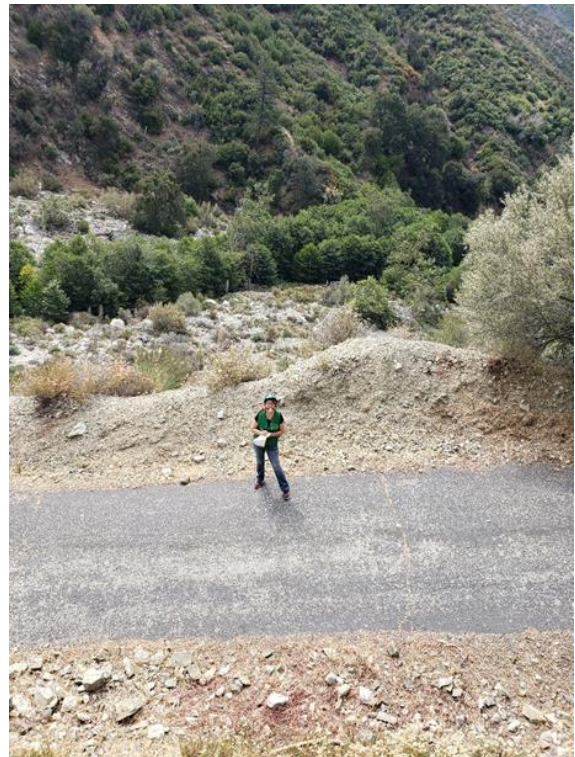
Figures 41 and 42: Figure 41 (left) shows the size of a fracture along the foliation plane in the felsic gneiss by the Sierra Powerhouse Access Road with Figure 42 (right) showing my mom taking notes from measurements.

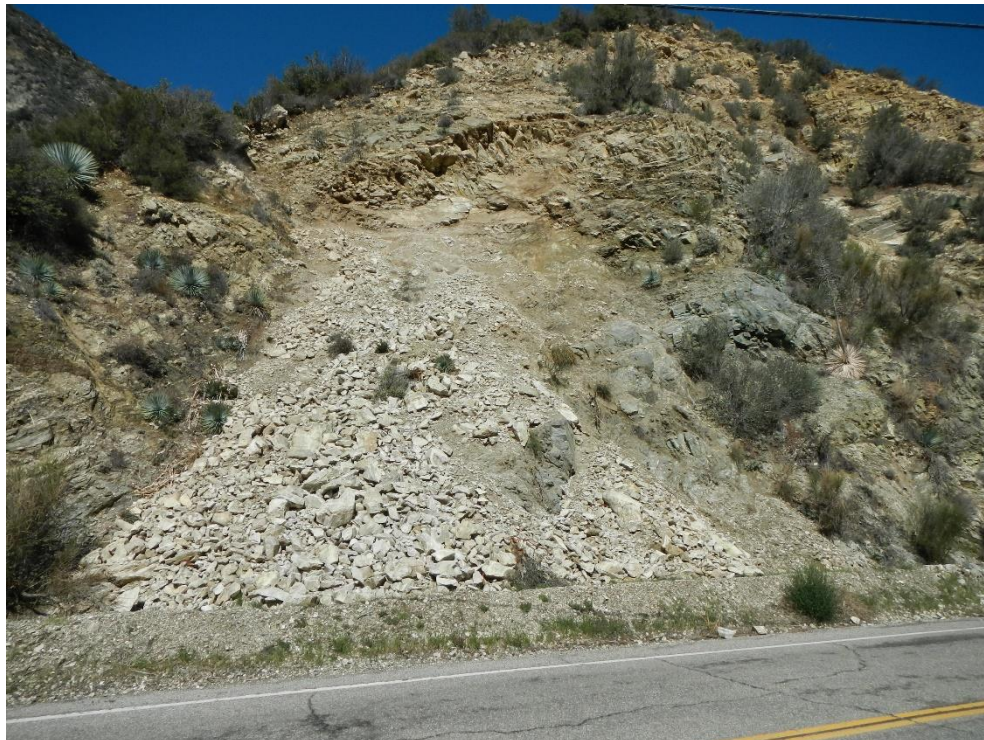
Figure 45: Image of LS3 which is north of the parking area on October 30th, 2019.

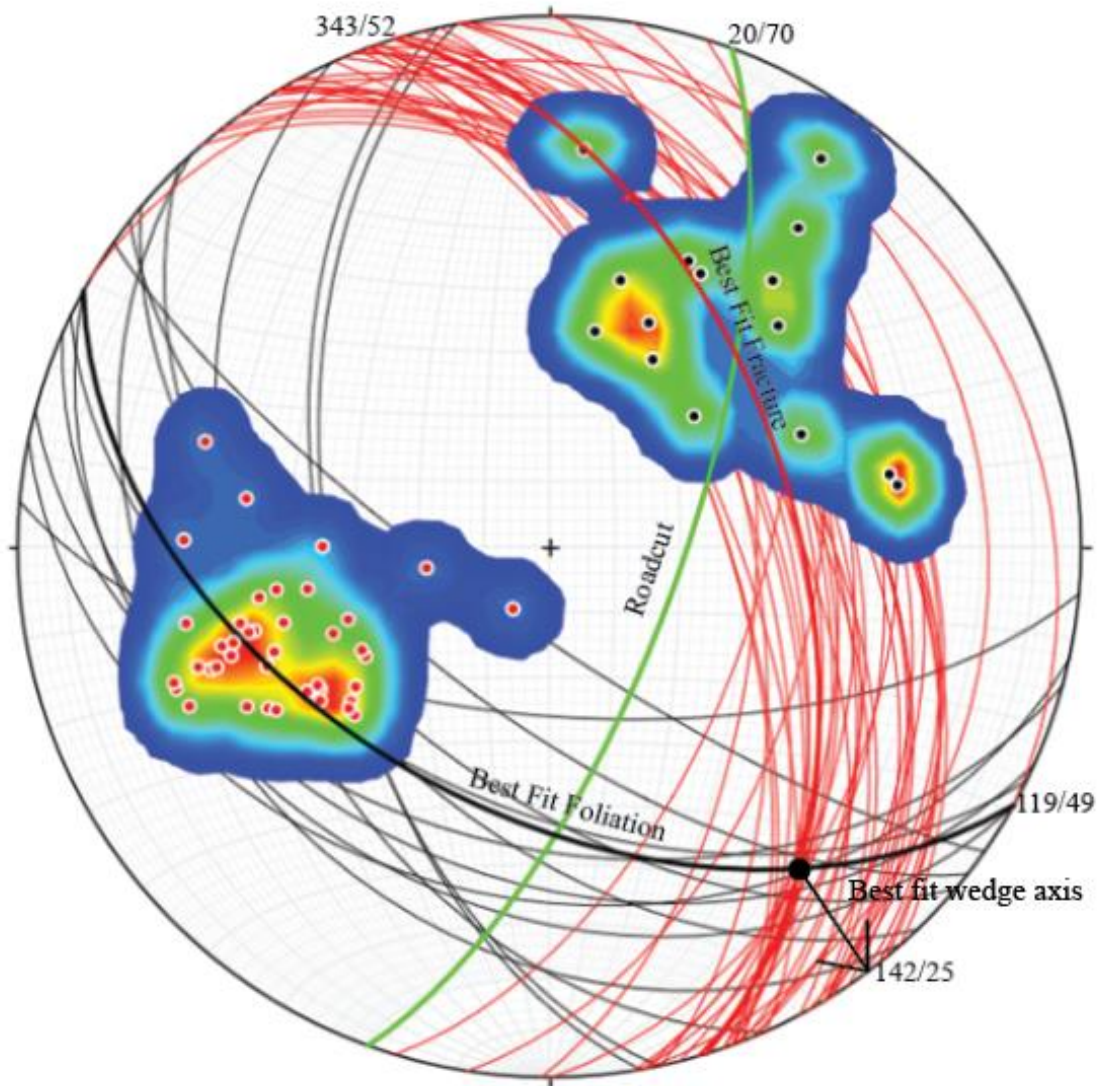
The stereonet of Fig. 48 shows fracture orientations at landslide (LS1) that comprise of the wedge surfaces observed. A multitude of measurements were able to be taken on the southern surface that was dipping to the northeast as it was a larger overall surface area and was overall easier to get access. Looking at the original stereonet without poles or contours plotted reveals the overall tendencies of both of the faces of the surfaces. On the southern side, there is an overall dip to the northeast varying in dip from 19 to 64 degrees and strikes from 300 to 17 degrees. Most of the strikes ranged from 330 to 355 degrees with dips between 33 and 59 degrees. On the northern face of the wedge dips in the foliation of the felsic gneiss were 34 to 78 degrees southwest with the steeper dips on the lower parts closer to the wedge axis. Strikes on this part ranged from 95 to 170 degrees with majority being between 114 and 138 degrees. Contours of the poles from the surfaces show a tighter cluster for the measurements on the southern slope versus those of the northern slope. The stereonet contains the poles to show the contours for these measurements along with the roadcut in green which is orientated N20E with a 70SE dip. Average slopes of the two planes were calculated leading to an intersection which would be the wedge axis. The best fit trend and plunge for this axis was 142/25 to be used in the safety factor section. Figure 49 shows the 3D intersection of these best fit planes and the wedge axis that forms.

Figure 48: Black lines showing strike and dip on the north face of the wedge (LS1) with red being the south. Parallel fractures follow closely to the red which suggests a fracture pattern in the area. Average strike and dip of the north face is 119/49 while for the south was 343/52, both shown in bold lines. Green line is the roadcut.

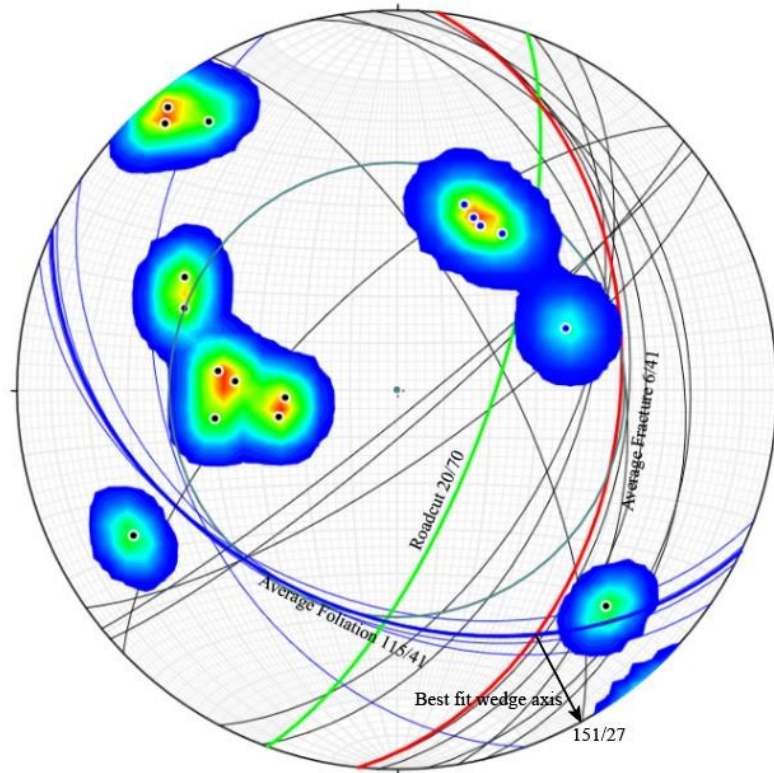
Measurements taken around LS2 show that the foliation intersects with most of the fractures at angles less than 40 degrees and much of the major intersections occur outside of the friction circle envelope therefore wedge failure is unlikely unless other factors (e.g lower ϕ , water pressure) are considered (Fig. 53). Some east-dipping fractures in this area are in the daylighting portion though throughout the area north of the wedge landslide. One wedge landslide (LS2) has been observed in this area which was relatively smaller in comparison to LS1 (Fig. 54) and slide LS3 that occurs further north of this part of the study area. Comparing the east dipping fractures to the roadcut suggests that several fractures have a steep enough dip and are within the 15 degrees of strike of the original roadcut to be considered daylighting planes. Some portions of the fractures have epidote while others

do not with the main slide surface containing the mineral. The trend and plunge of this wedge axis is 151/27.

Figure 53: Measured fractures (black) and foliations (blue) with roadcut (green) around LS2. Average fractures in bold red and foliations in bold blue. Circle represents 40 degrees friction circle for reference.

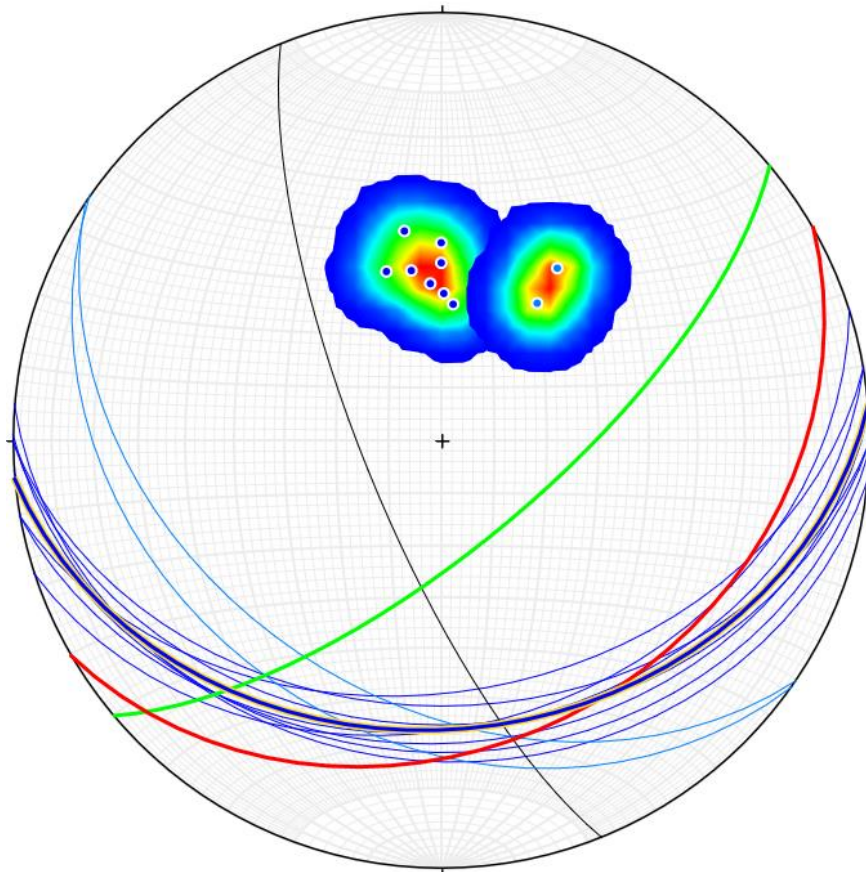
The landslide site located furthest north from the wedge and north of the parking lot was called LS3. Compared to nearby road cuts, foliation orientations had changed significantly at the base area where things could be measured reasonably by Dr. Nourse. Slopes were slippery and difficult to scramble up so most of the measurements were made on the bottom portion of the landslide no higher than 15 or so feet in elevation from the base (Fig. 55). A few fractures, including the presumed slip surface were sighted from the base of the slope. These foliation-controlled fractures were striking more or less west while dipping to the south from 26 degrees to 41 degrees. The strike of the roadcut was at about N50E with an assumed original dip of 70SE. The strike of the slide surface itself was at about N60E with an approximate dip of 30 degrees to the SE putting it within the daylighting envelop; i.e., within the region where plane intersects with the roadcut causing it to be out of slope. In comparison to the roadcut, the steepest measured foliation was N72E 34SE. It was not difficult to see that the foliations upslope, nearer to where the failure occurred, are subparallel to what the landslide plane was inferred to be (Fig. 56).

Figure 56: Showing the LS3 surface in red (60/30SE), foliations under the surface in blue with bold being the average strike (85/33SE), normal foliations south in light blue and the roadcut in bold green (50/70SE) with one fracture in black.

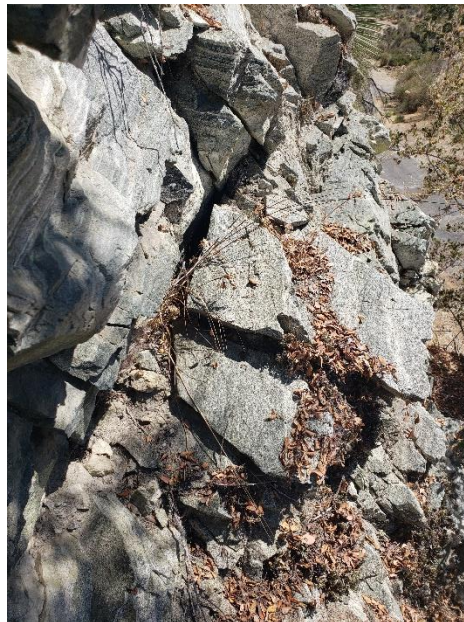
By far the area with the most diverse and complicated fractures was underneath the lookout between the Mt. Baldy Road and the Sierra Powerhouse access road (Fig. 27c). Foliations were consistent throughout the area and similar to those along the Baldy Rd. above with strikes ranging from N65W to N22W and dips ranging from 23 to 49 degrees to the SW. Fractures were clustered in scattered groups with most dipping to the NE as observed in other parts of the study region. However, there were several other clusters not observed at other sites (Fig. 57). It could be that these measurements were taken on blocks that were out of place as some had peculiar orientations. It was not uncommon to see boulders which had slumped and become out of place because of it (Fig. 58).

Figure 58: Fractures and foliation below lookout.

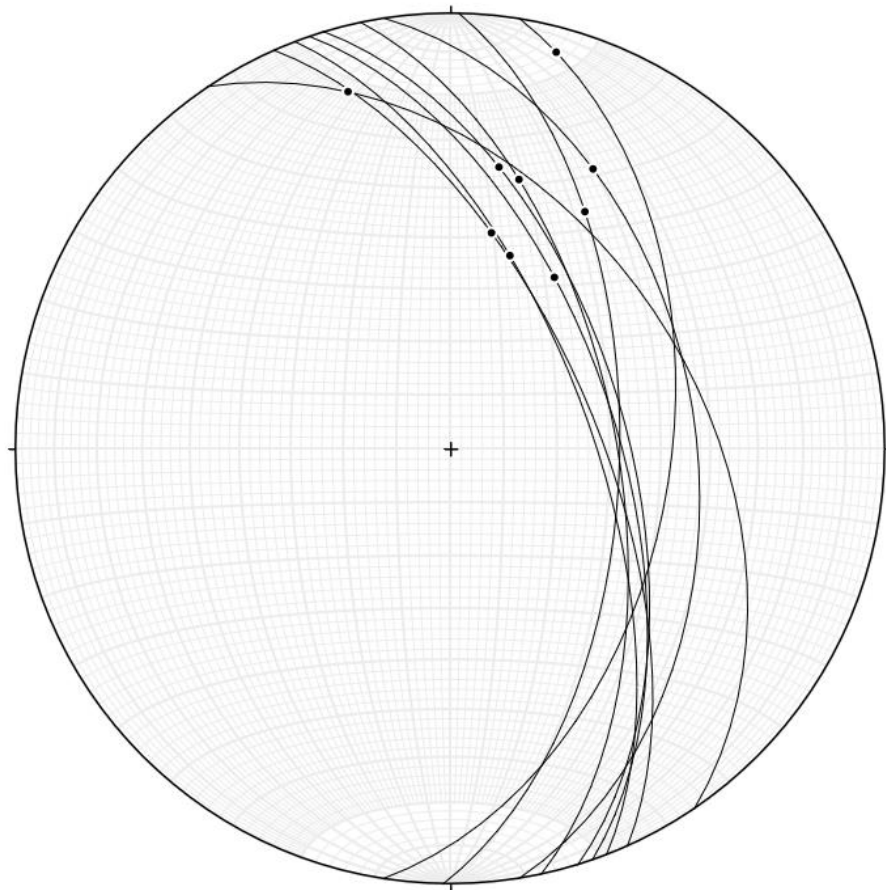
Rakes were measured on some of the striated epidote surfaces at the LS1 site. These represent micro faults in the area with some movement on them during time periods in the past (Fig. 59). The shallow to moderately plunging striations represent strike slip fault activity probably related to the ancestral San Antonio Canyon Fault (Nourse, 2003). Much of these measurements were taken along fracture surfaces in and around the area of LS1.

Figure 59: Epidote data where lines are striated fault planes and dots are the striations. Taken within the LS1 surface on the southern plane.

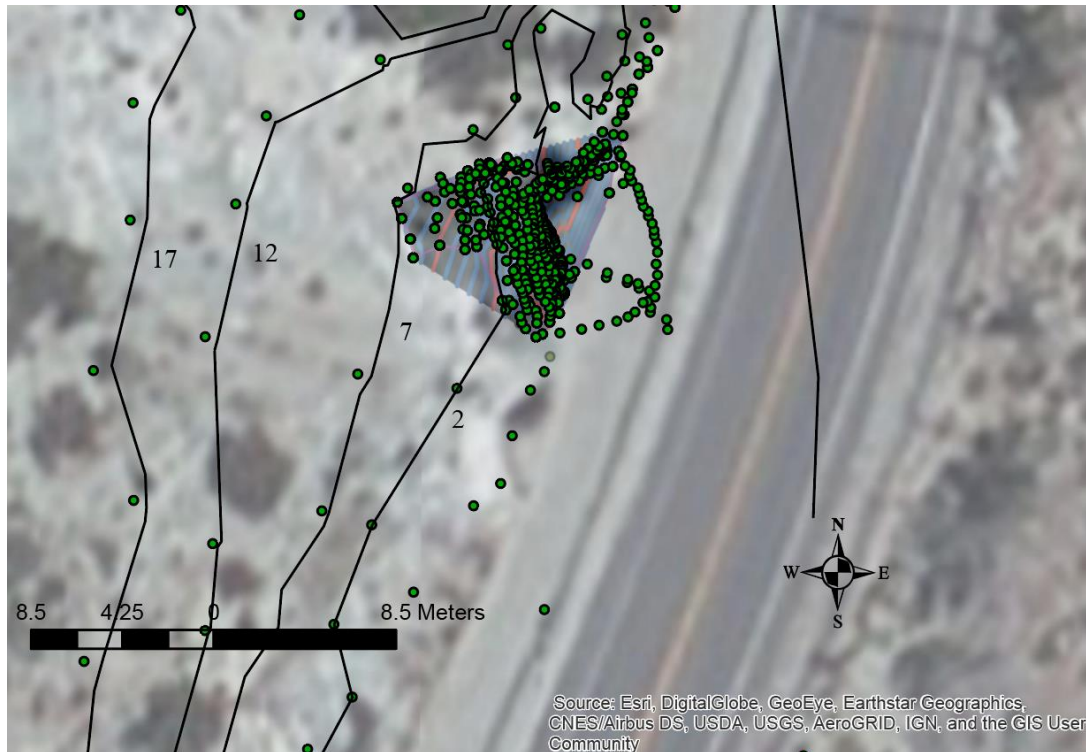
Figure 61: Zoomed out map showing context for volume calculations of Fig. 62. Contours are in m.

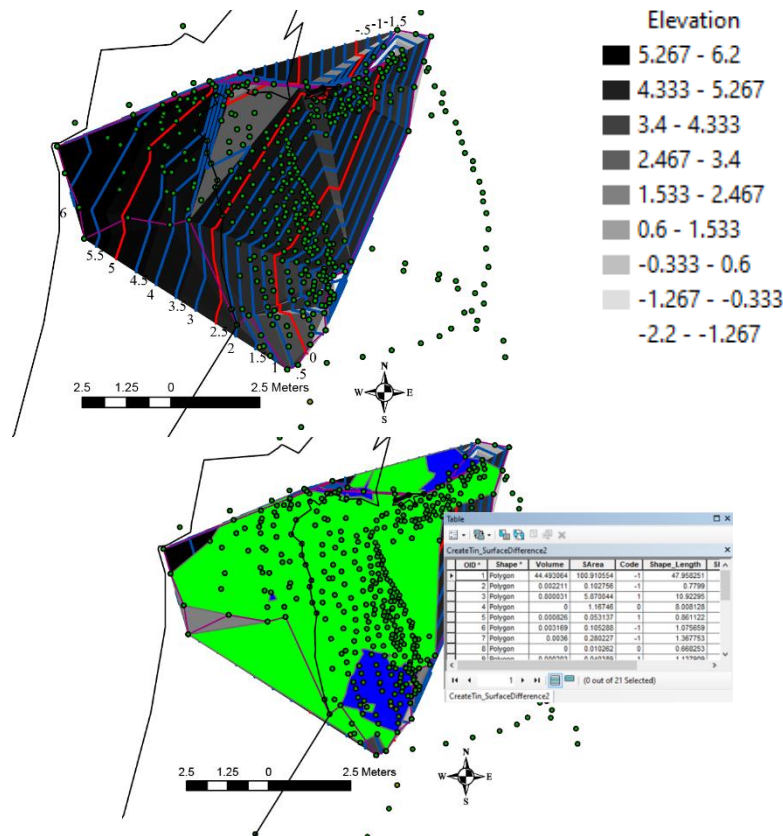
Figure 62: ArcGIS method using various polygons to determine the volume missing under the wedge's (LS1) original surface. Laser rangefinder data was used to first create a 3D model of the wedge followed by using edge points to create an original surface mesh from which individual polygons can be used to see how much volume is missing. Volume units are in m^3 . Contours .5 m intervals.

It should be noted that this approach gives a greater volume to that of using the cone method as missing volume represents an aggregate of many past failures while the debris cone represents a single event. Final volume was $43.69m^3$ after accounting for a $.8m^3$ discrepancy. Some of the volume seems to appear to be above that of the original surface but the volumes are insignificant in nature so the outcome of the calculations through the program are unaffected. More detailed description with images of steps can be found in the methods section.

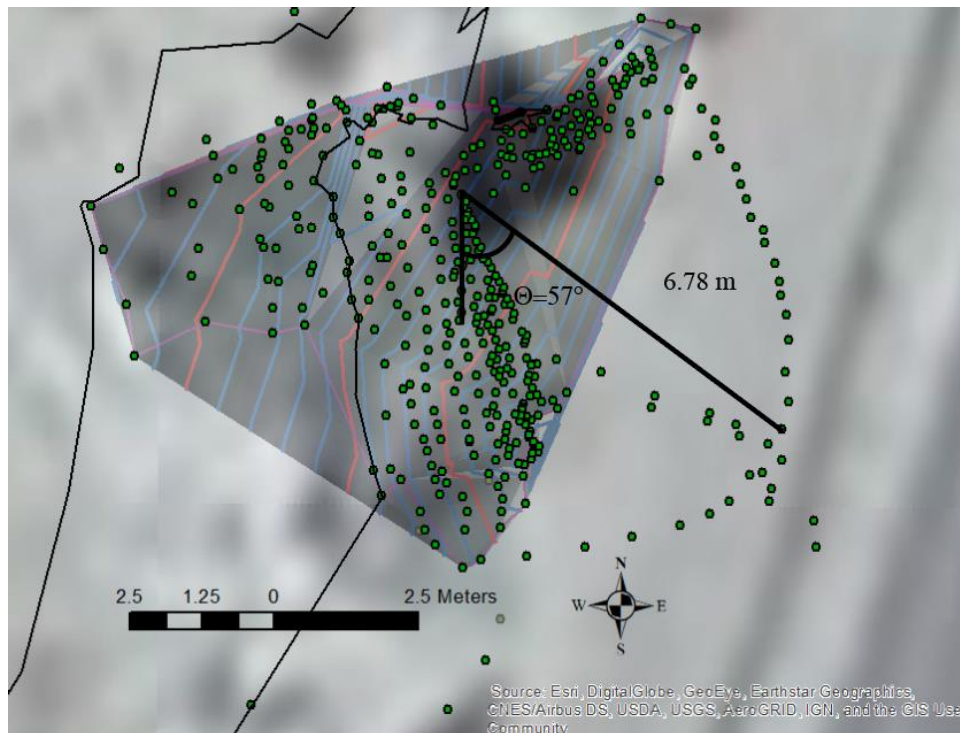
Figure 63: Radius measured on ArcGIS also along the cross-section line.

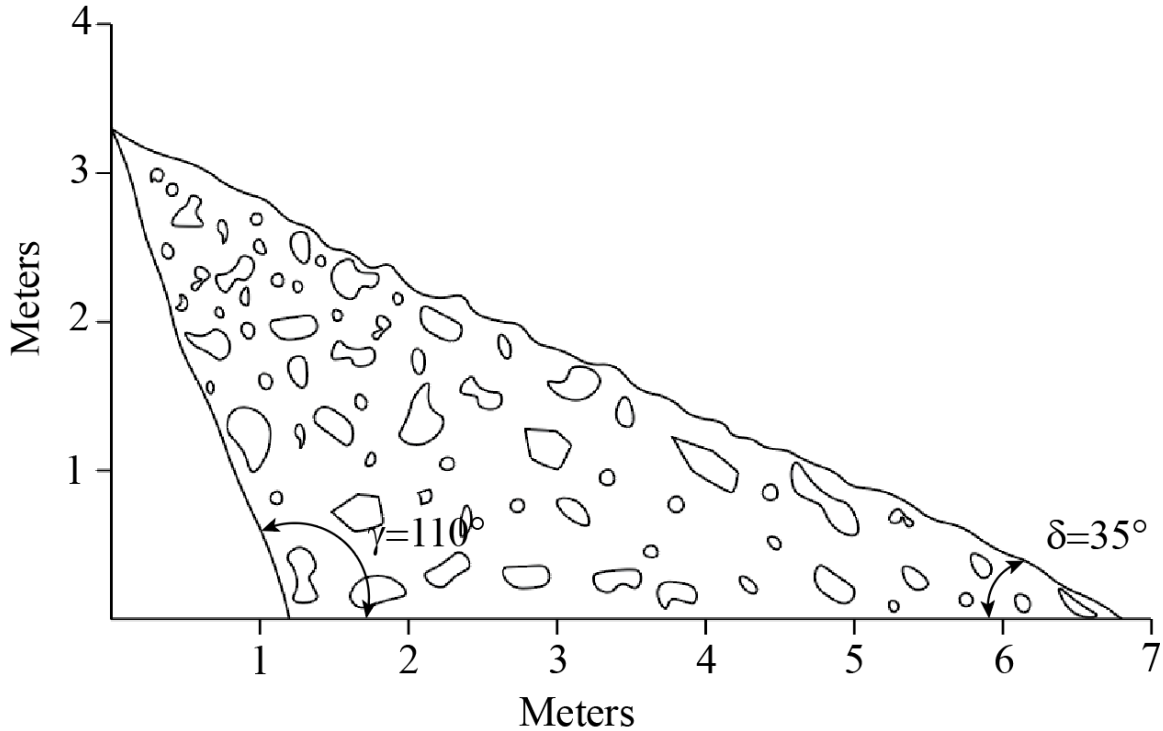
Figure 64: Cross section of cone for LS1.

When it comes to the cone of LS1, quite a bit must be assumed about what were the original dimensions of the cone when it initially failed. Even in 2017, the photographs taken seemed to be more for the debris that came down from above versus the actual dimensions of LS1 so comparisons to the LS2 cone were made to get a rough approximation of what they would have been. For larger boulders, the cones seemed to favor being at about a 45-degree angle so the radius would be similar to the height though the height is not used in this instance. However, the cone observed had a base angle of around 35 degrees so that is what is used (Fig. 64). The measured radius was about 6.8m. Cut position of the cone was estimated to be at around 57 degrees with a base angle of 35 degrees and a cutting angle of 110 degrees yielding a volume of 26.5m^3 or 935.8ft^3 .

To determine the weight of the slide mass, the cone volume was multiplied by the approximate unit weight of rock which is 160 lbs/ft³ and also by .7 to account for the 30% porosity estimated for rocks in the cone of a landslide after failure for a final weight of 104,810 lbs. For comparison of the volumes, it is approximated the volume of the cone would be about 18.55m³ when accounting for porosity while the ArcGIS estimation was 43.69m³. A larger original cone with a radius of 7.2, base angle of 45 assuming larger and more angular rocks, and a cut position of 60 degrees would yield a cone slightly larger than the one computed on ArcGIS at 44.5m³.

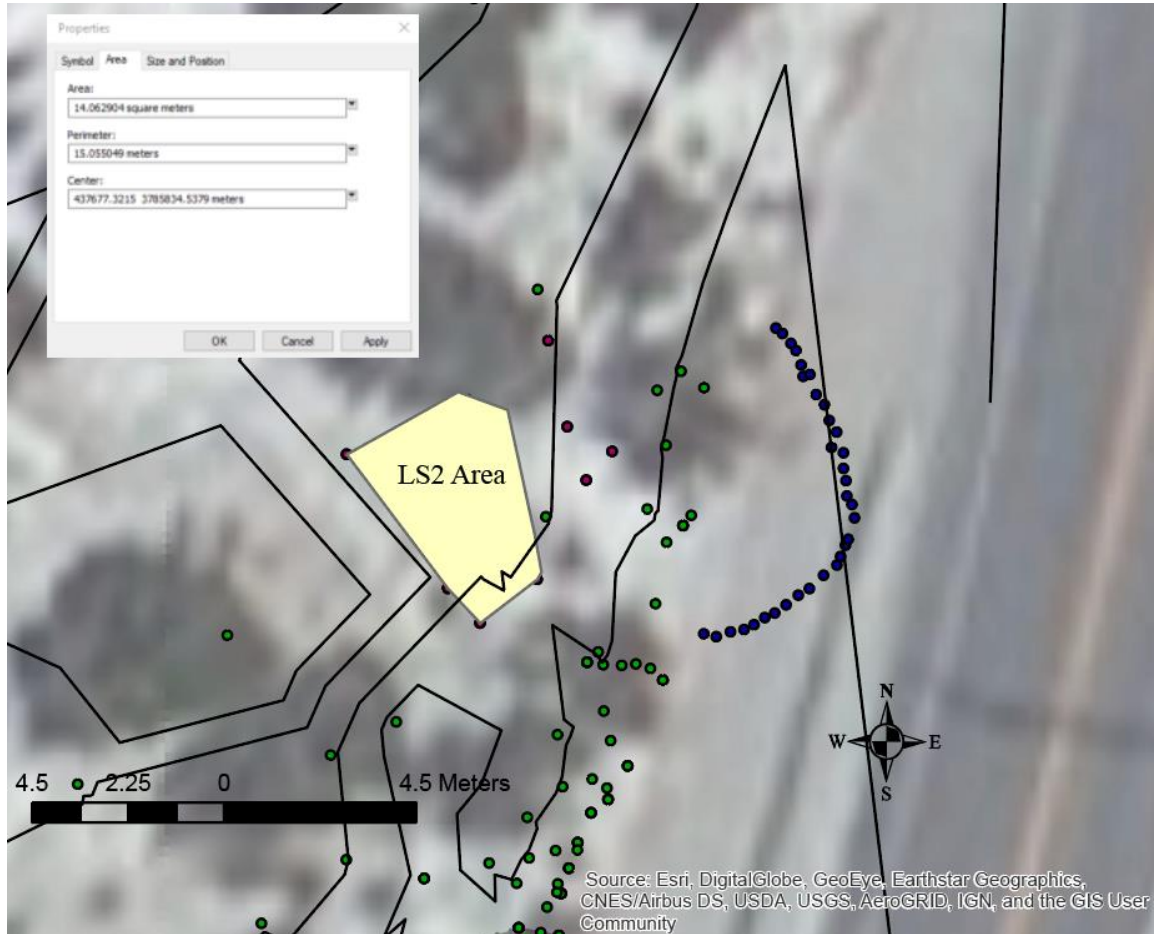
LS2 required the use of only the cone data in order to be able to approximate the volume of material which had destabilized and come down from the slope since brush in the area caused for unreliable reading on the obscured surfaces. Figure 66 shows the area of the landslide surface was approximated using the laser rangefinder while referencing Figure 67 in the field to be imported into ArcGIS later. Using the interpolate polygon with heights in ArcGIS, the surface area of the slide surface was found to be about 14.1m² based off the approximate area in Figure 68. The next step was to take measurements from the cone of LS2 from the images (Fig. 69) and measure the diameter to then get a radius of about 3.68 m, base angle of 45 degrees, 70 degrees on the cut position and a cut angle of 110 yielding a volume of 15.3 m³. This result multiplied by .7 to take into account 30% porosity yields a volume of 10.7 m³ which is then converted to 377.9 ft³ for a final weight of 60,464 lbs.

Figure 66: Showing LS2 slide surface in beige with its area measured on the little box. Blue dots represent the outline of the cone for the slide with green dots along the higher parts of it.

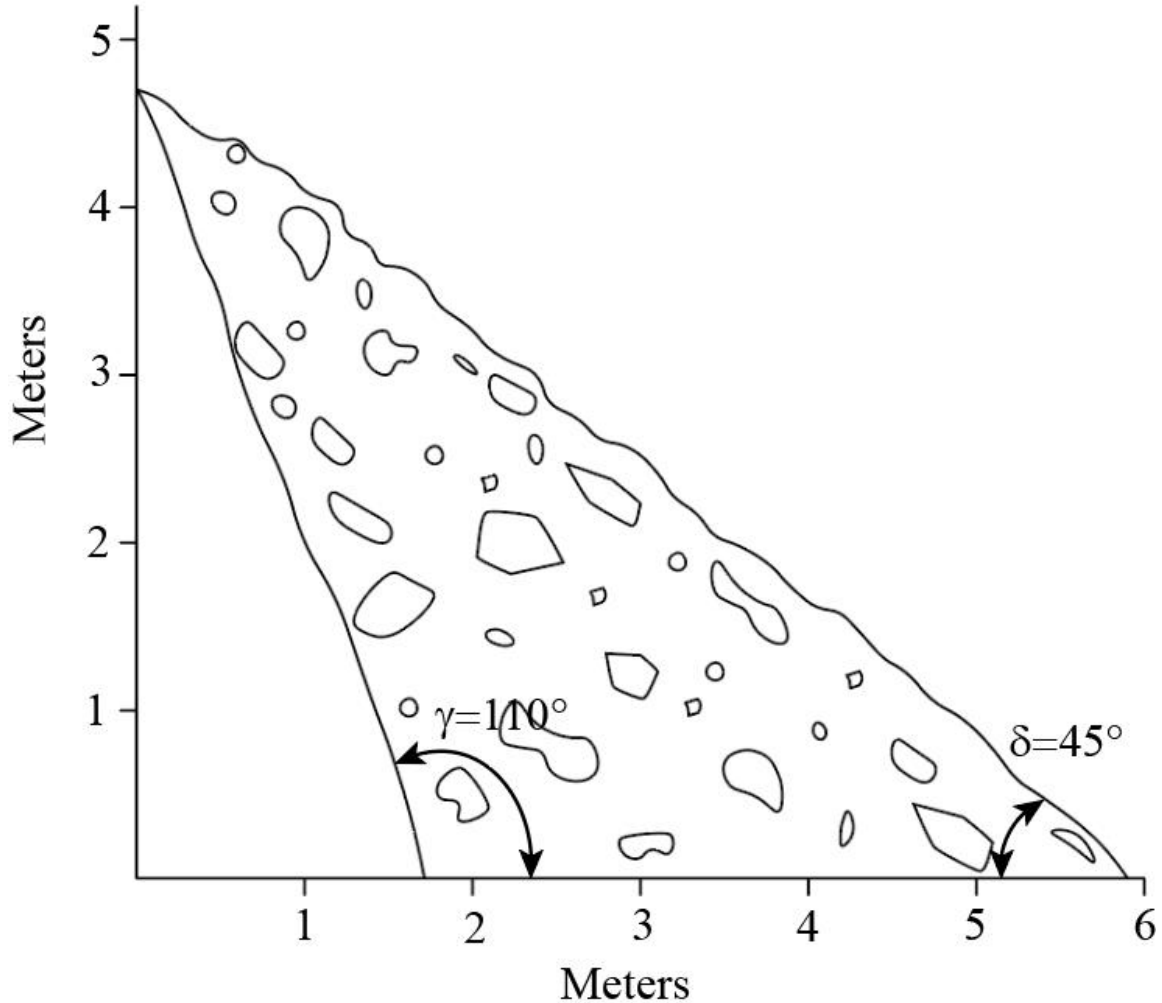
Figure 69: Cross section of cone for LS2.

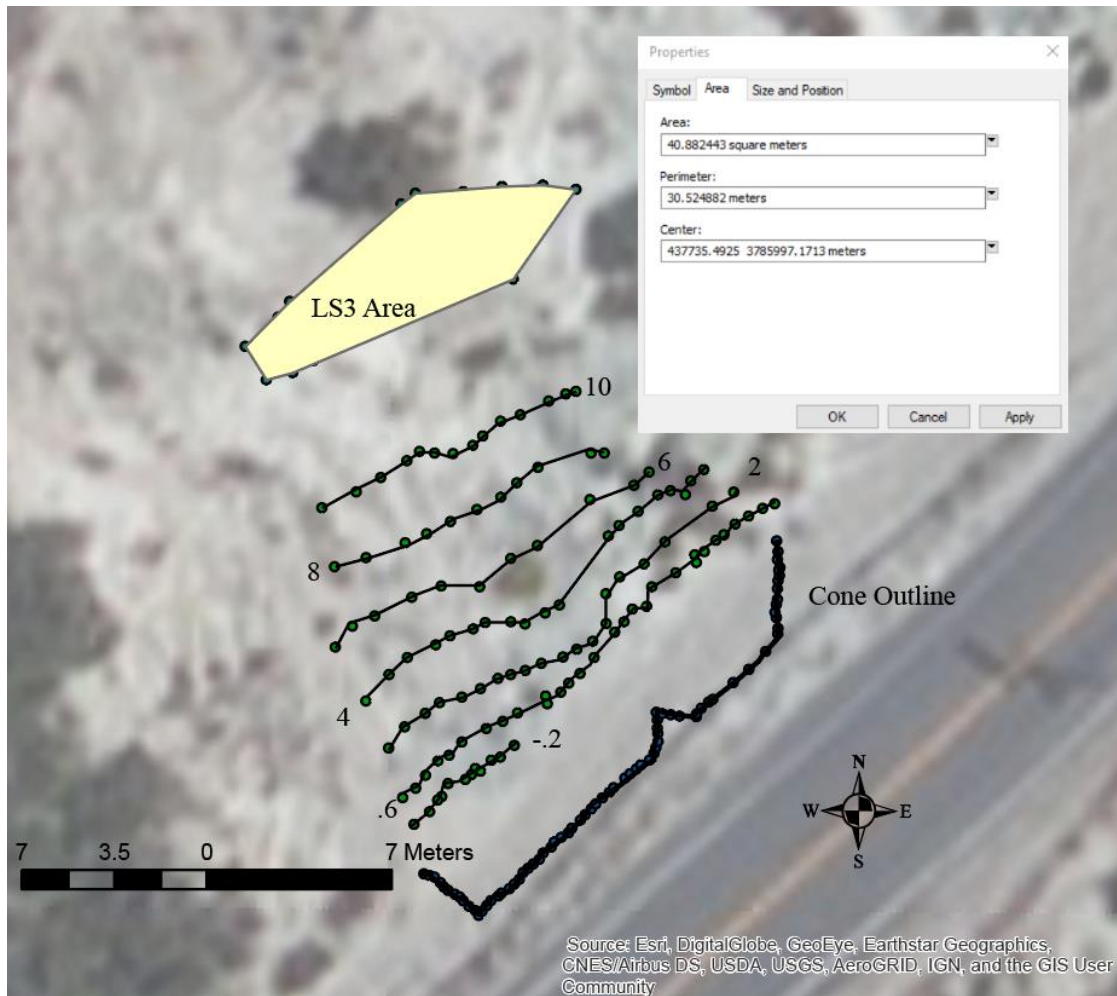
LS3 data was derived from measurements of the suspected landslide surface (Fig. 71) using the same method as in LS2 to derive an area of 40.9m^2 (Fig. 70). This area could be larger as explained later. Measurements of the debris cone (photographed in 2019; Fig. 72) were done on ArcGIS to calculate the radius of the cone (Fig. 73). It is assumed that the radius from the measured cone of 10.1 m, base angle of 30 degrees, cut position of 70 degrees and a cut angle of 110 degrees resulted in a volume of 155.9 m^3 . This result multiplied by .7 to take into account 30% porosity yields a volume of 109.1 m^3 which is then converted to 5505.6 ft^3 to result in a weight of 616,627 lbs (279697 kgs).

Figure 70: LS3 exposed slide surface area calculated on ArcGIS from imported rangefinder data.

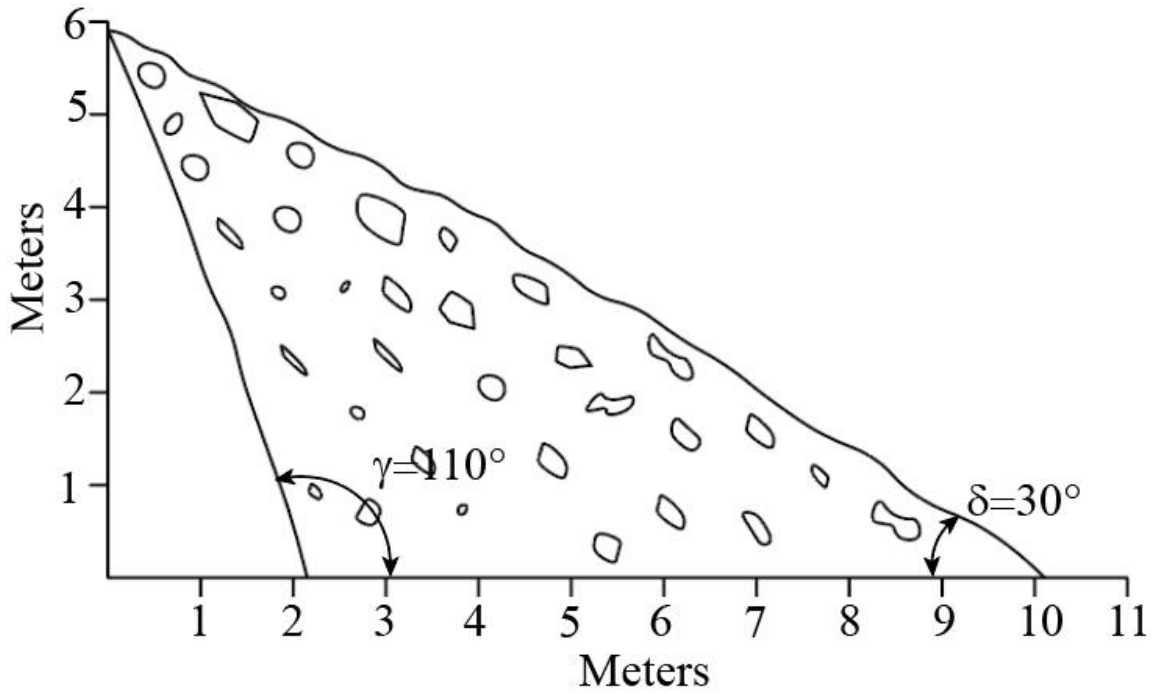
Figure 73: Cross section of cone of LS3.

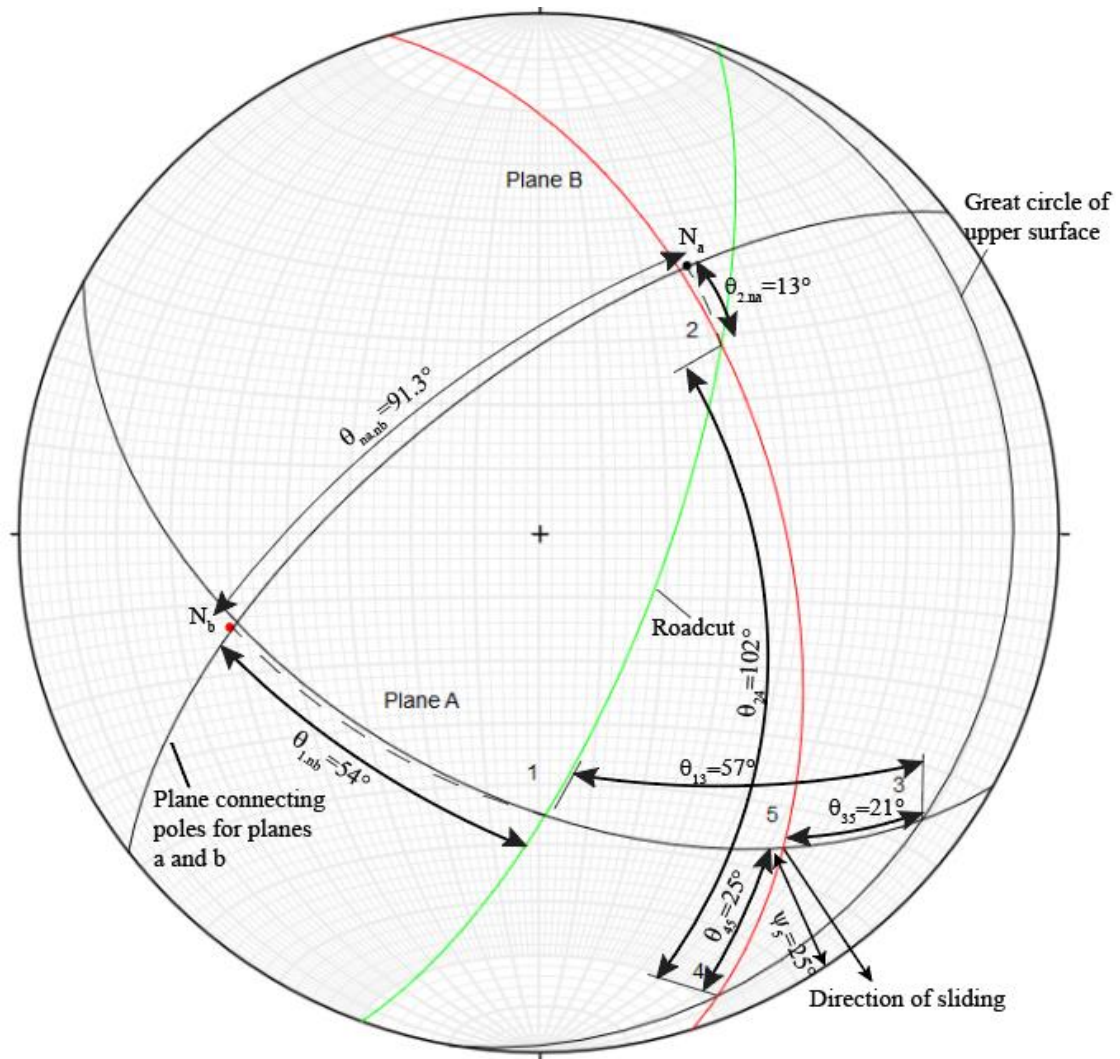
Figure 74: Stereonet showing pertinent planes and angles used in LS1 complex safety factor equation.

Table 2 shows the way in which the four variables for the equation are solved for using the parameters measured on the stereonet in Figure 74. Once these values were solved, they were input into excel using the standard weights for both the rock and water with one of the water weights being set at 0 for the dry case in Table 3. The resulting values of cohesion necessary to maintain a safety factor of 1 after the point where the friction angle goes down to a critical point.

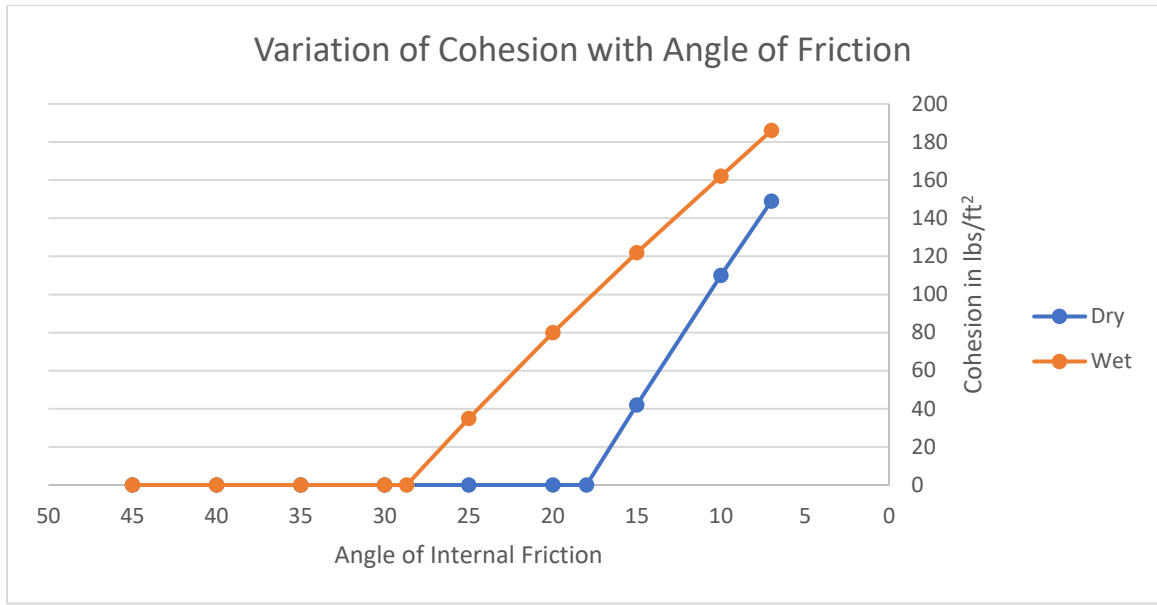
Figure 75: Chart showing the variation of cohesion with respect to the angle of friction needed to create a safety factor of 1 under dry and wet conditions.

Graphical analysis of the results (Fig. 75) shows some reasonable patterns under the dry and wet conditions. In the dry case, cohesion is not necessary to stabilize the slide mass until friction angle dips below 18 degrees. This landslide was stable under normal conditions that assume a 25 degrees friction angle for epidote but failed because of the change under wet conditions as cohesion was needed for values below 28 degrees. Cohesion values required for stability are low which should be expected due to the small scale of this slide and the material that consist of the plane (Appendix B). Low values correlated by infilled fractures as shown in the table of the plate. Larger cohesion values likely would be needed to overcome any driving forces to the magnitude of those observed in the Hogback Landslide. All of these values seem to be reasonable given the conditions under which these events took place.

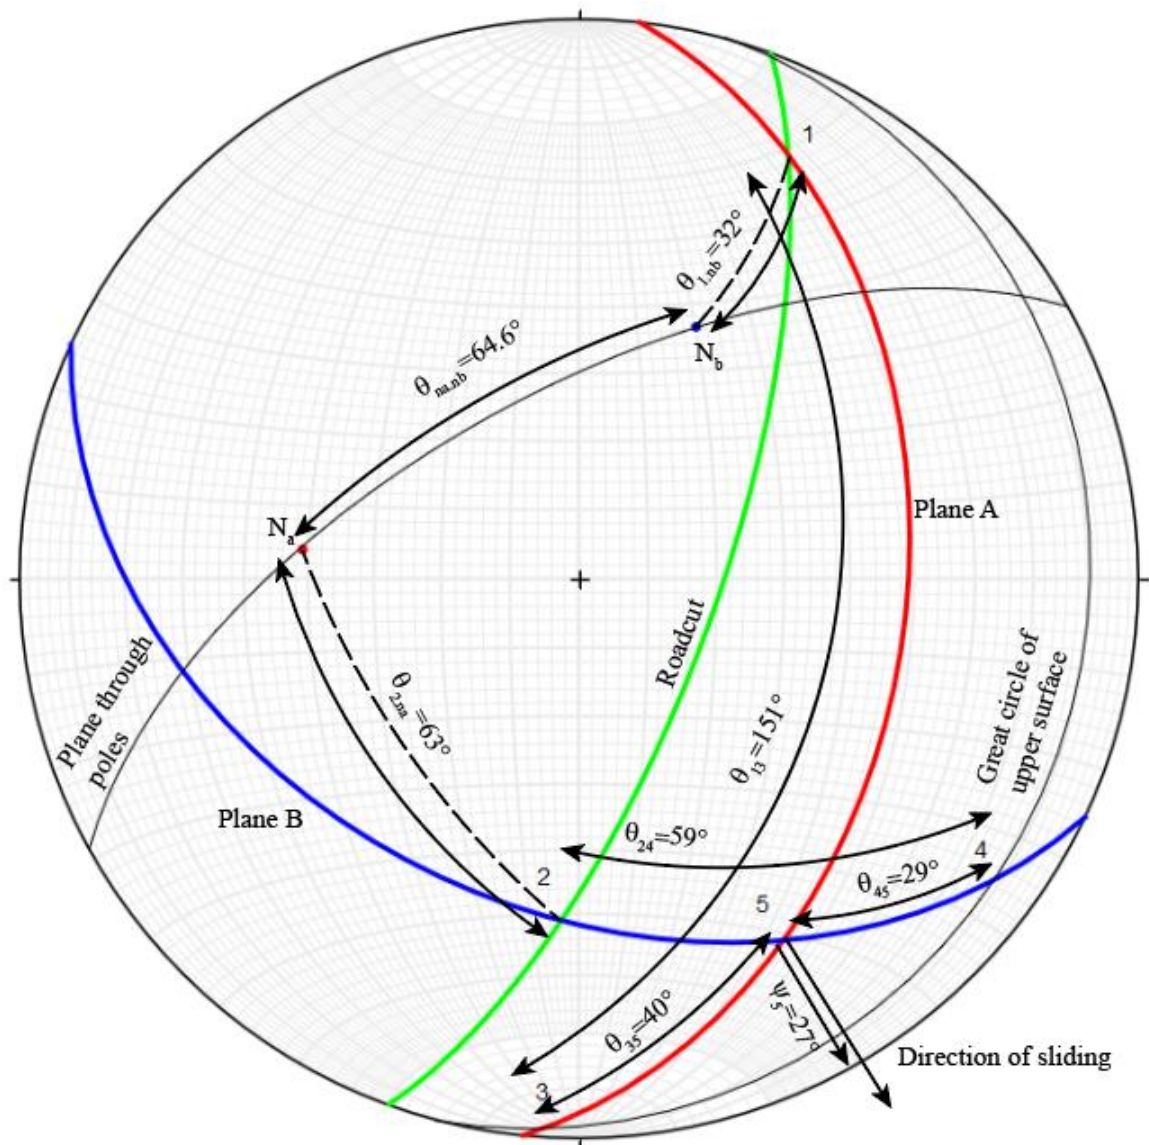
LS2 used the same approaches as LS1 when it comes to finding the values needed from a stereonet (Fig. 76) to plug into the equations to solve for the variables X, Y, A and B for the complex equation. These values are then written down in Table 4 to solve for the four variables before going on to the final step of solving for the values. Parameters are plugged in to solve for cohesion values to maintain a safety factor of 1 in Table 5.

Figure 76: Stereonet showing pertinent planes and angles used in LS2 complex safety factor equation.
