THESIS TITLE LANDSLIDE FAILURES ALONG MT. BALDY ROAD AND TESTING OF METHODS TO BACK CALCULATE
AUTHOR Andrew Garcia
PROGRAM Geology, M.S.

**LANDSLIDE FAILURES ALONG MT. BALDY ROAD AND TESTING OF
METHODS TO BACK CALCULATE SAFETY FACTOR**

The area around Mt. Baldy Road to the west of the San Antonio Canyon within the San Gabriel mountains is an area which has had a multitude of both small and large scale landslide failures during its history. The purpose of my study is to look at three small events (LS1, LS2 and LS3) that happened recently and investigate different methods to back calculate their safety factor parameters. I completed eleven trips to the area measuring orientations of fractures with the help of a GPS to constrain locations. Fractures plotted on stereonet revealed features needed to assess slope stability. A laser rangefinder was used in conjunction with ArcGIS to create high-resolution topographic maps in the areas near the landslides. These maps and related data manipulations facilitated volume calculation of debris cones and allowed me to estimate the missing volume at LS1 site.

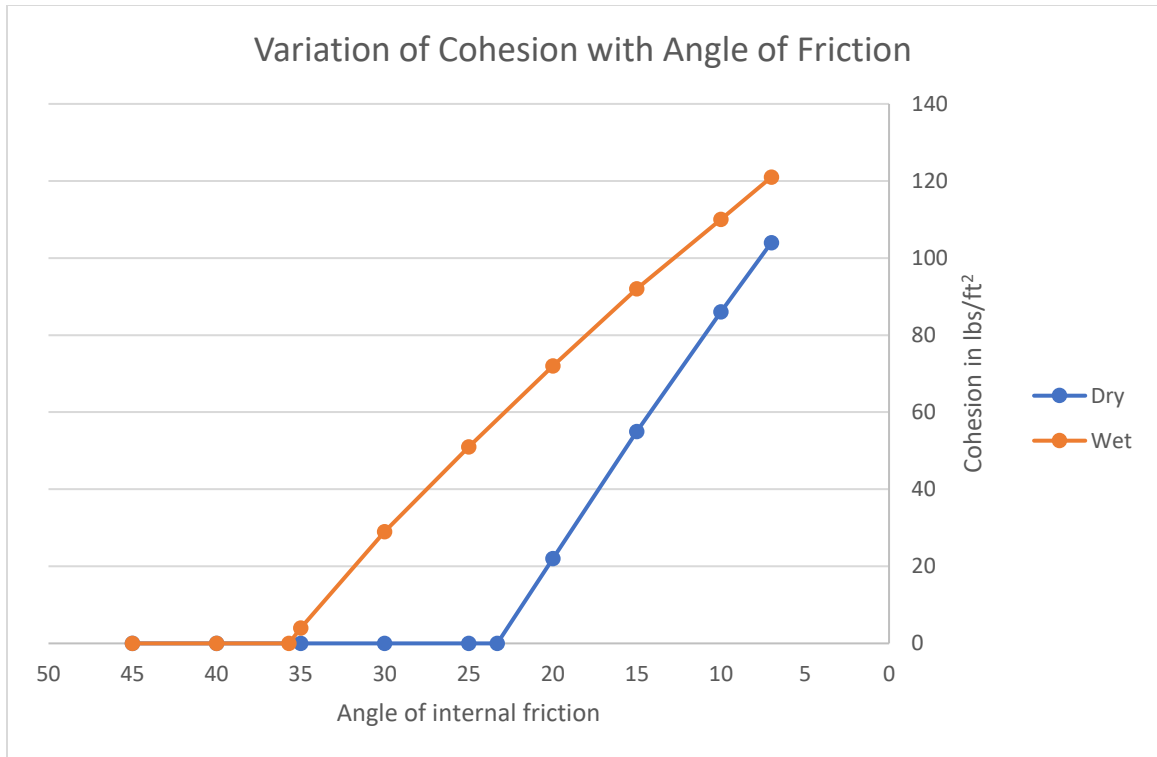
Figure 77: Chart showing the variation of cohesion with respect to the angle of friction needed to create a safety factor of 1 for LS2.

Graphical analysis of the results (Fig. 77) shows some reasonable patterns under the dry and wet conditions for LS2. Cohesion is not necessary to stabilize the slide mass until friction angle dips below 23 degrees under dry conditions. This landslide was stable under normal conditions that assume a 25 degrees friction angle for epidote but failed when wet conditions were introduced as cohesion was needed for values below 35 degrees. Low values of cohesion were once again expected like in the case of LS1 due to the small size of the failure. All of these values seem to be reasonable given the conditions under which these events took place in with infilled fractures dictating cohesion (Appendix B).

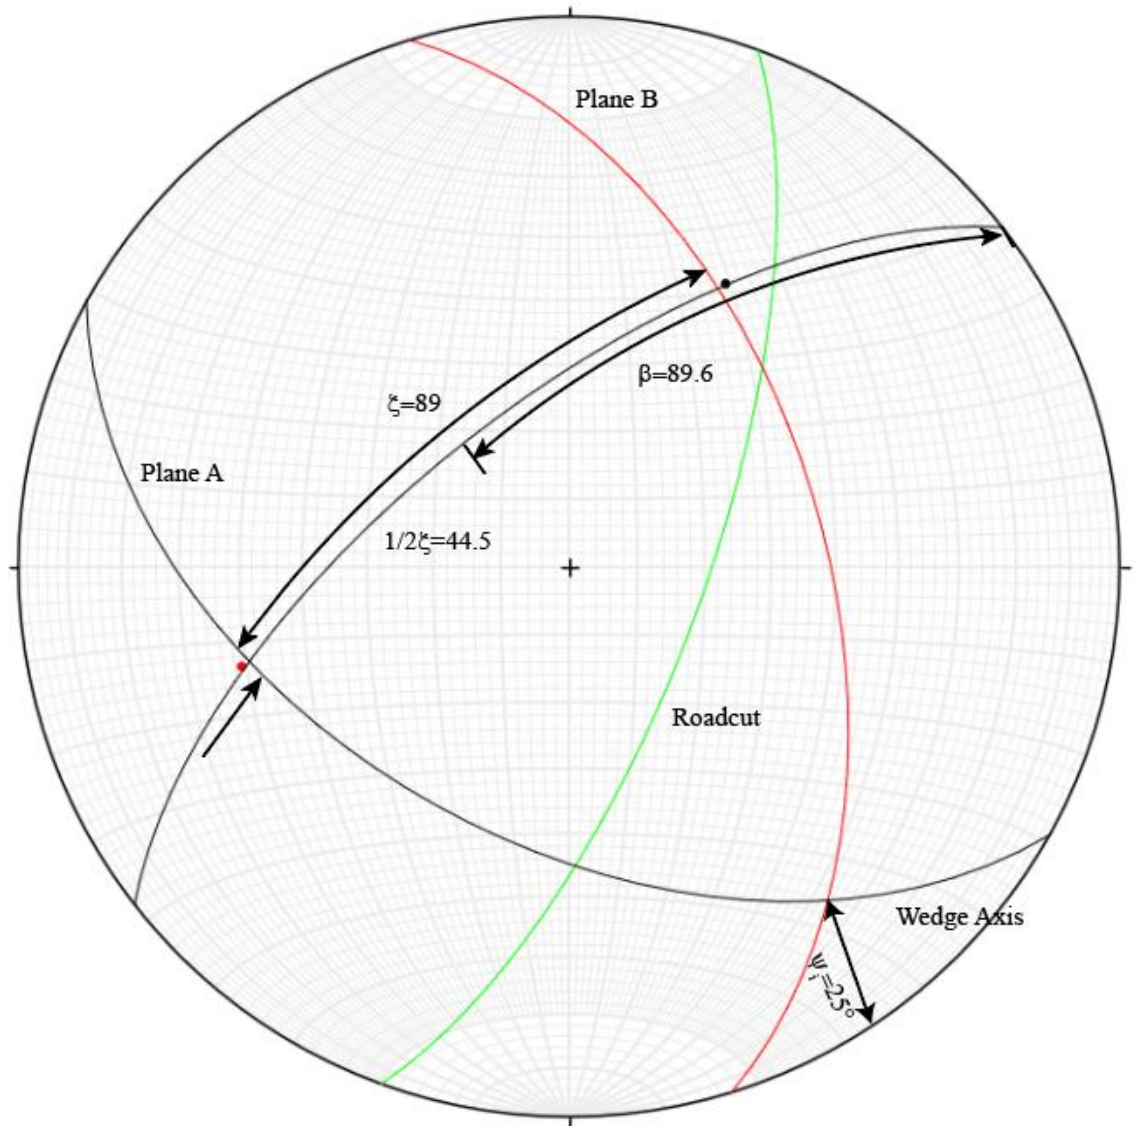
Values needed to input into the equation above will be found on the stereonet in Figure 78 which were measured in the stereonet program to solve for LS1. Half of the angle between the planes along with the one from the center to the ground surface were measured along the stereonet for input into the safety factor equation. Weight cancels out in the zero-cohesion case so it will be displayed as a comparison between the two methods to find volume but is not relevant to the final equation setup in Table 6. Plunge of the wedge axis was also referenced on the stereonet though an additional one would be solved for assuming a steeper wedge axis in Table 7.

Figure 78: Summary stereonet diagram showing planes and angles used in friction only safety factor calculation at LS1.

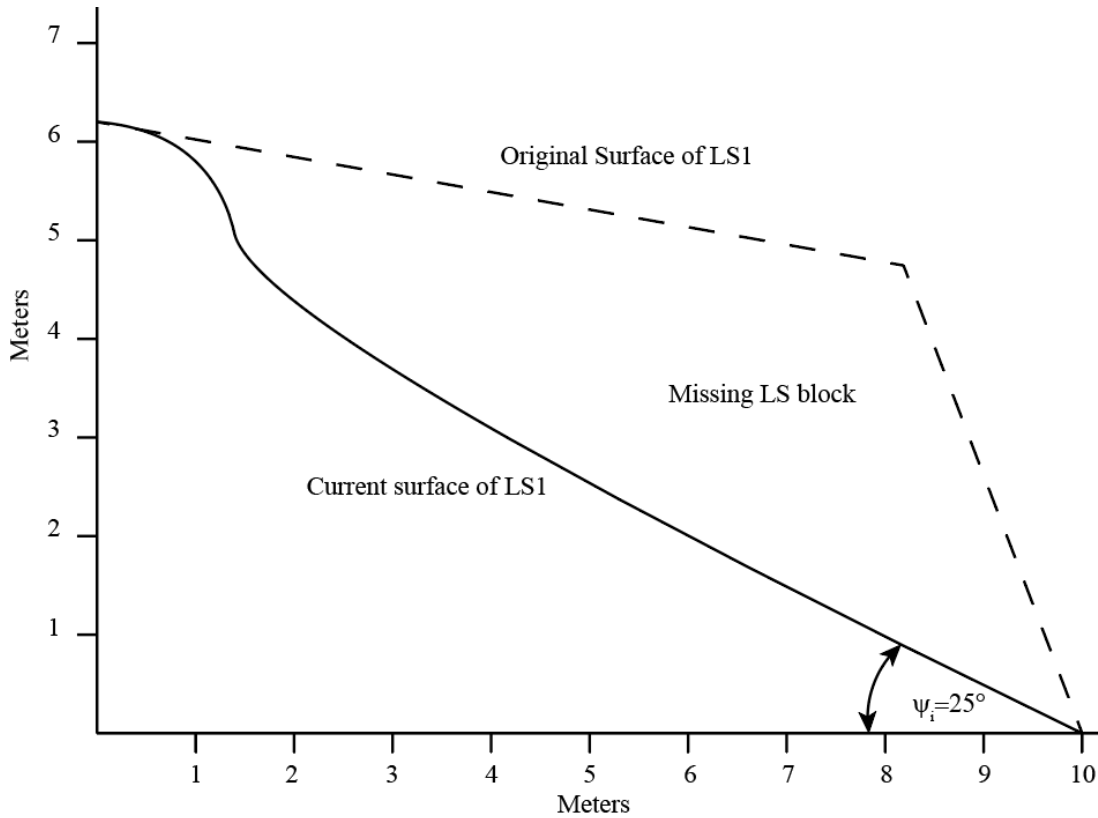
Figure 79: Cross section of LS1 showing the approximate original surface and the current surface showing the line of intersection of the two planes also known as the wedge axis.

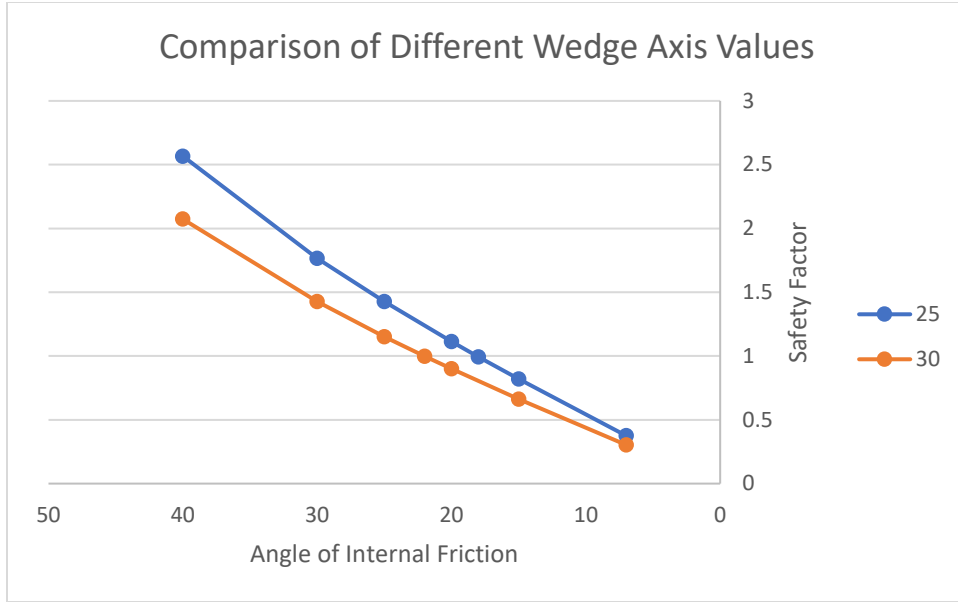
Figure 80: Chart comparing safety factor values with ψ_i values of 25 (blue) and 30 (orange) for LS1 under friction only case with $C=0$.

It can therefore be concluded that under conditions in which there are no other outside influences, this wedge failure would not have begun due to a safety factor higher than one. A lower friction angle would be needed in order to drive the safety factor low enough to be unstable. There still is enough of a drop-off that the difference a few degrees would put this landslide into the failure zone at a slightly higher dip value. This is displayed in Figure 80 where ψ_i are solved for values of 25 and 30 degrees. The reason why a higher angle was also solved for was to see the effect of a higher value due to other intersections happening at these increased dips show in Figure 48. Back calculations are not possible for cohesion since the only variable which is able to be changed is the angle of friction.

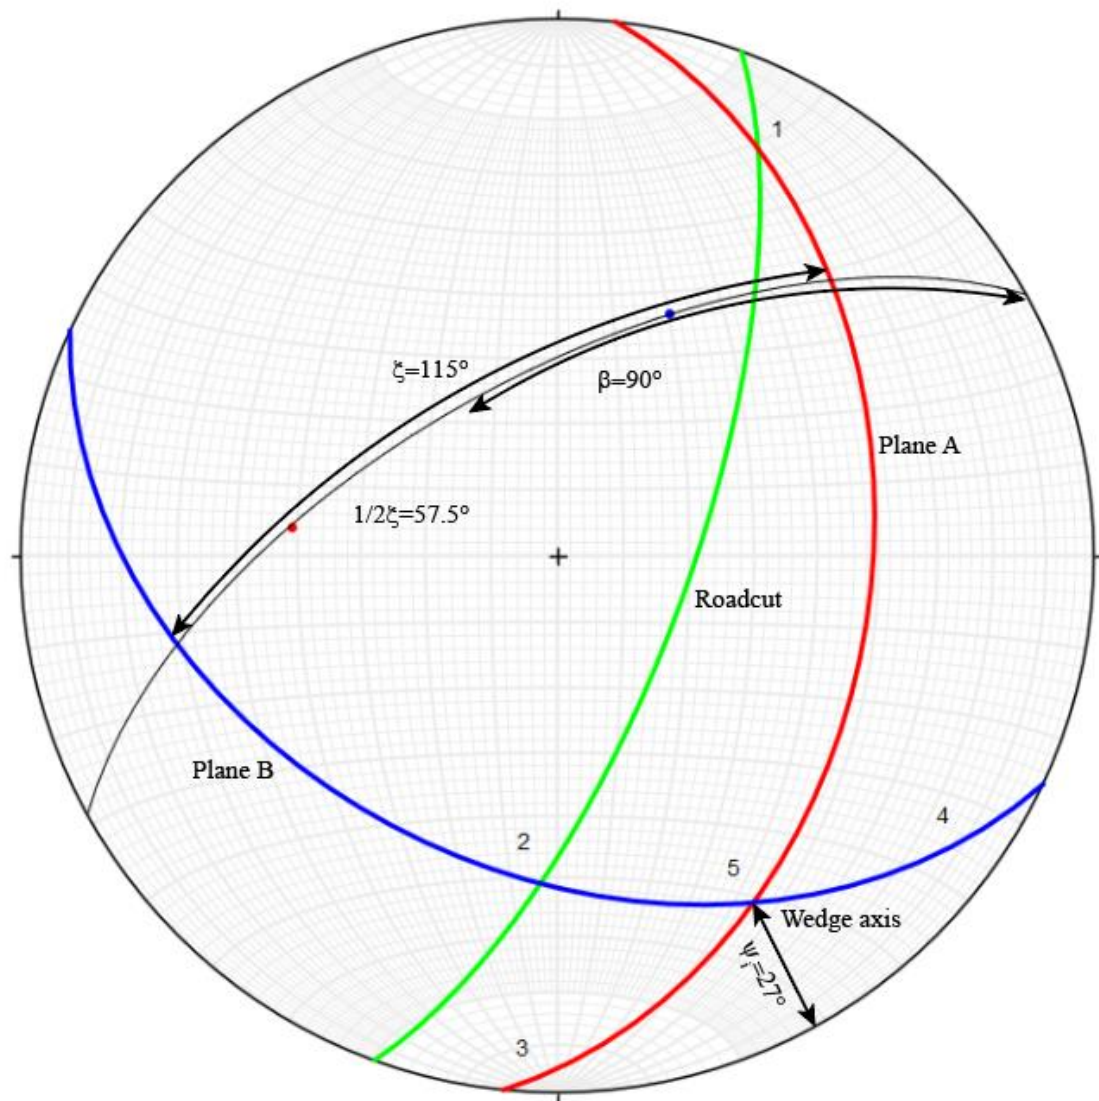
The same procedures to find the friction only case for LS1 was applied to LS2 when using a stereonet (Fig. 81) to find the values of ξ and β for use in the formulas. Table 8 shows the results of the calculations for both the measured ψ_i value of 27 and one of the steeper angles which was suggested on the stereonet from Figure 53. A cross section was created in Figure 82 to show the angle of wedge axis needed schematically.

Figure 81: Stereonet showing friction only parameters for LS2 to be used in the friction only equation.

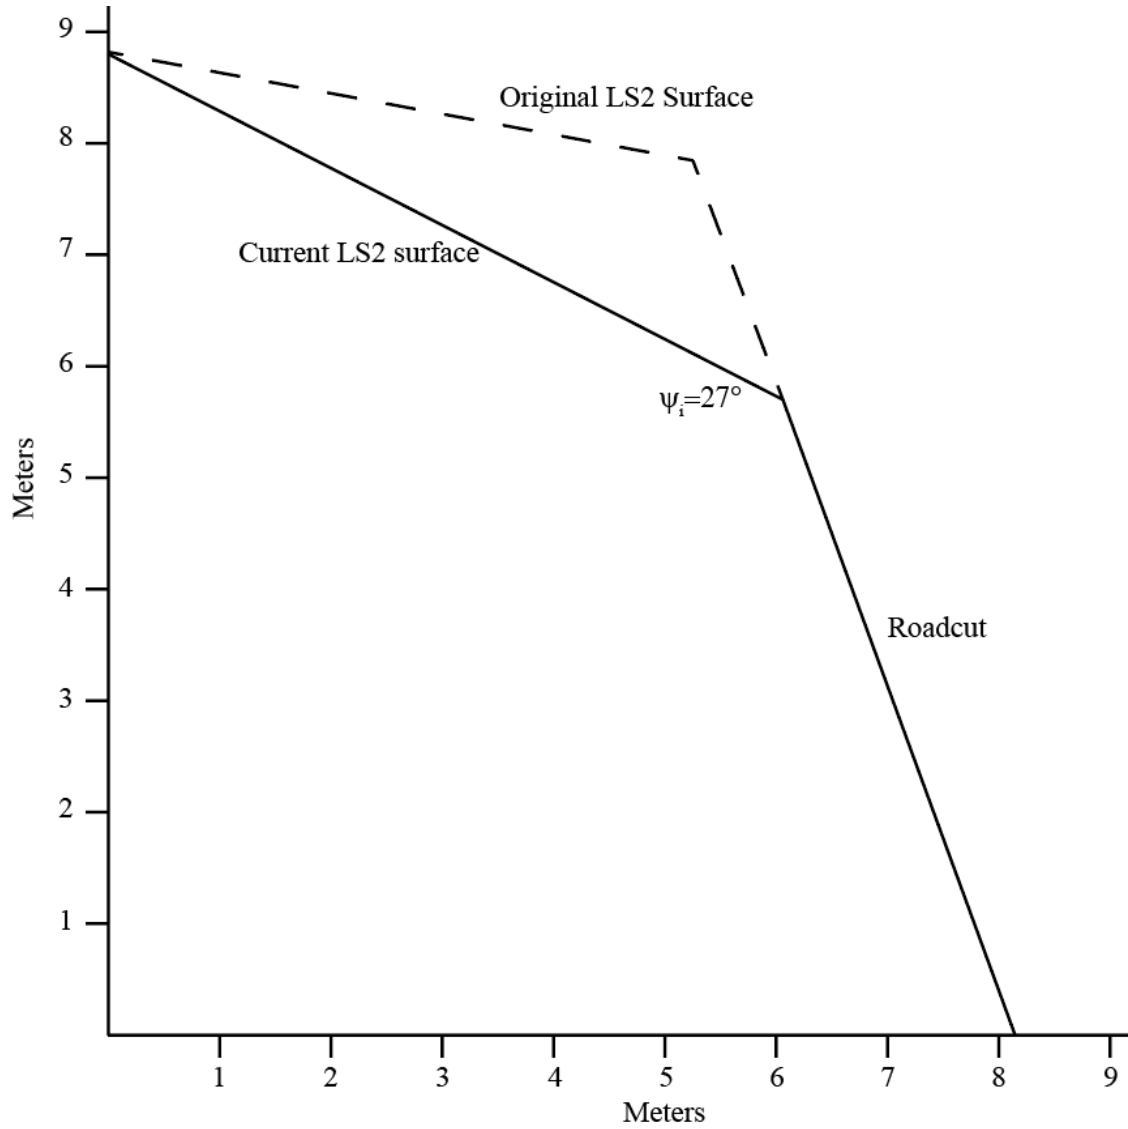
Figure 82: Cross section of LS2.

Wedge failure would not have occurred in circumstances where only friction was affecting the failure as seen in Table 8. Outside variables were in play in order to have failure occur at that point. An increase in the ψ_i value from 27 to 32 decreases the safety factor values at each respective angle with the most noticeable decrease occurring at the larger values (Fig. 83). This adjustment shows that more angles with the higher value could potentially have made it closer to the failure point at the average angle observed in the stereonet from Figure 80.

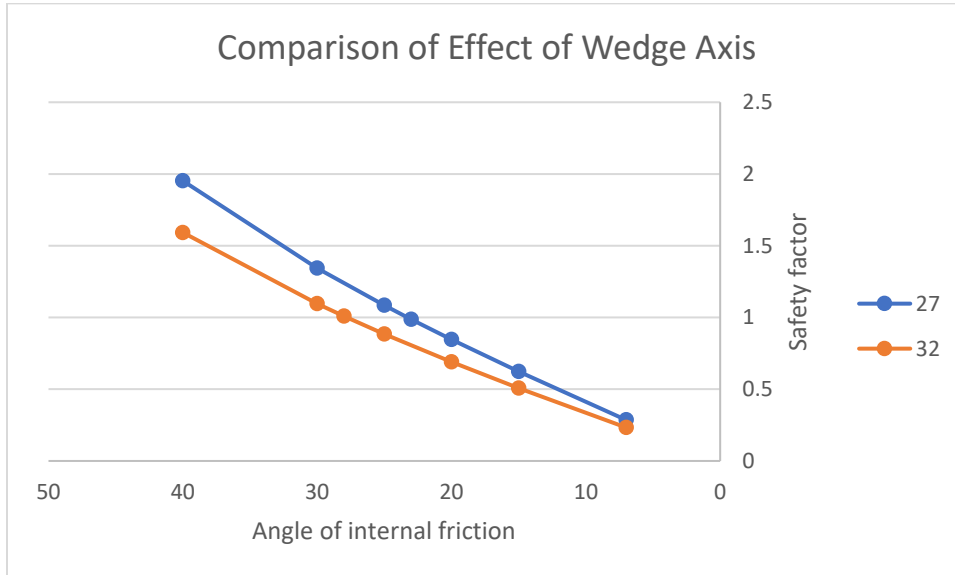
Figure 83: Effects of an increase in wedge axis on the resulting safety factor solution.

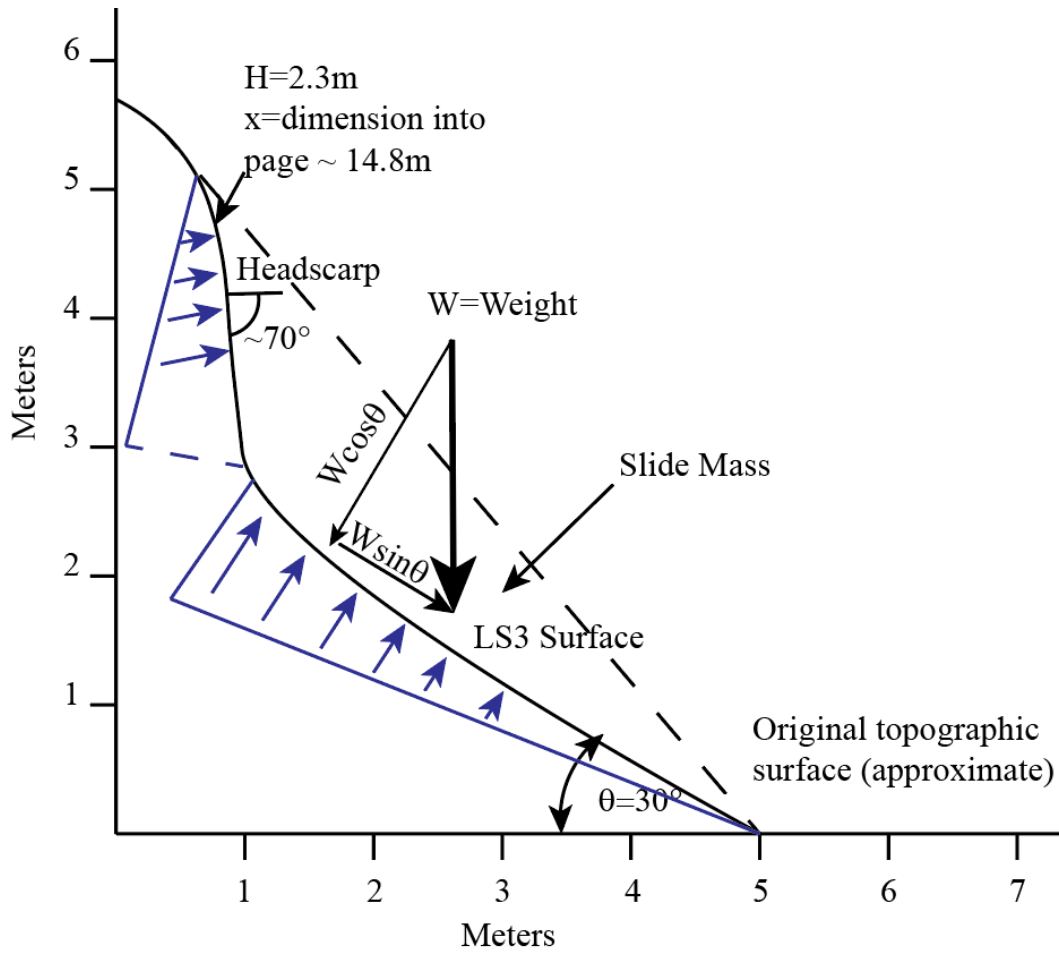
added subtraction of the pressure of water which acts within the slide plane. The first term which the pressure is being subtracted from is the pressure exerted per unit area of which the water pressure cannot be greater than. With a weight about 1/3 of the of the unit weight of the rock, it is safe to assume that the pressure within the slide plane area would be normally 1/3 of the of the pressure exerted by the weight on the surface. Figure 85 displays the different parameters needed to plug into this equation.

Figure 85: Cross section through LS3 showing water pressure effects.

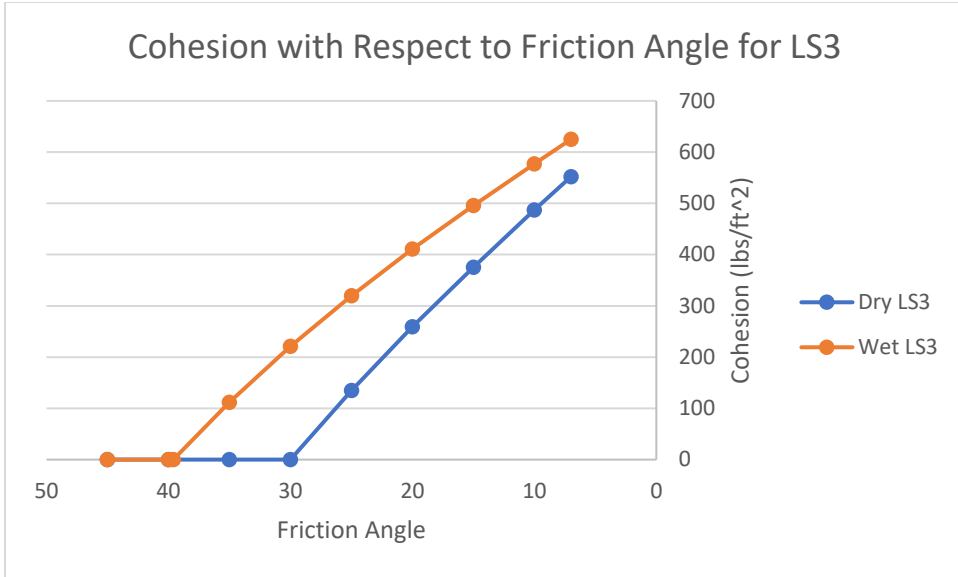
Table 11 uses the area which was measured on ArcGIS. Comparison of values under dry and wet conditions are shown in the table and a graphical comparison of the two conditions is provided in Figure 86.

Figure 86: Values of cohesion and friction needed to maintain a safety factor of 1 for LS3.

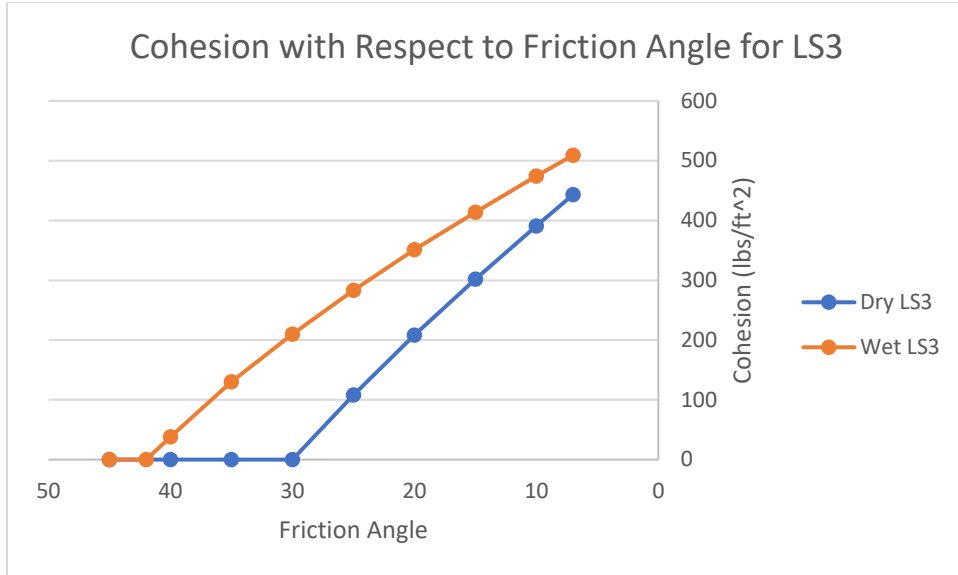
Table 12 and Figure 87 show the effects of an increase of 10m² on cohesion values in comparison to what was originally calculated initially. This increase in area was chosen in case some of the surface area was not visible. A decrease in the cohesion needed was observed.

Figure 87: Adjusted graph for an increase in 10m² of surface area.

Landslide 3 failed along a surface with a dip (θ) of approximately 30 degrees which is about equivalent with the dip of foliation. Foliations were daylighting on this northernmost slide which did have some fractures along the foliation planes. If the rock was blocky instead of having fractures along the foliation planes, a friction angle (Φ) 40 degrees instead of the 30 would have been applied. No epidote was seen up high, but the cohesion values needed for stability were 135 lbs/ft² (6.46 kN/m²) under dry conditions and 320 lbs/ft² (15.32 kN/m²) under wet conditions if epidote was present causing the angle of internal friction of failure to be 25 degrees under the measured area. Appendix B confirms that these lower values of cohesion are to be expected for infilled fractures. Cohesion was needed earlier for wet conditions to keep the safety factor one by an angle of internal friction of about 39.6 degrees which is to be expected due to the hydrostatic pressure which acts in the opposite direction of weight. An increase in the surface area of the slide surface to account for some potentially buried slide surface caused for lower

cohesion values to be observed in comparison to those calculations based off the area calculated from ArcGIS.
